# AERIAL SITEWORK PROGRESS REPORT

Construction & sitework documentation · grading, drainage and structures · capture date withheld

| Project | Site address withheld | Report ID | MWA-SMP-0004 |

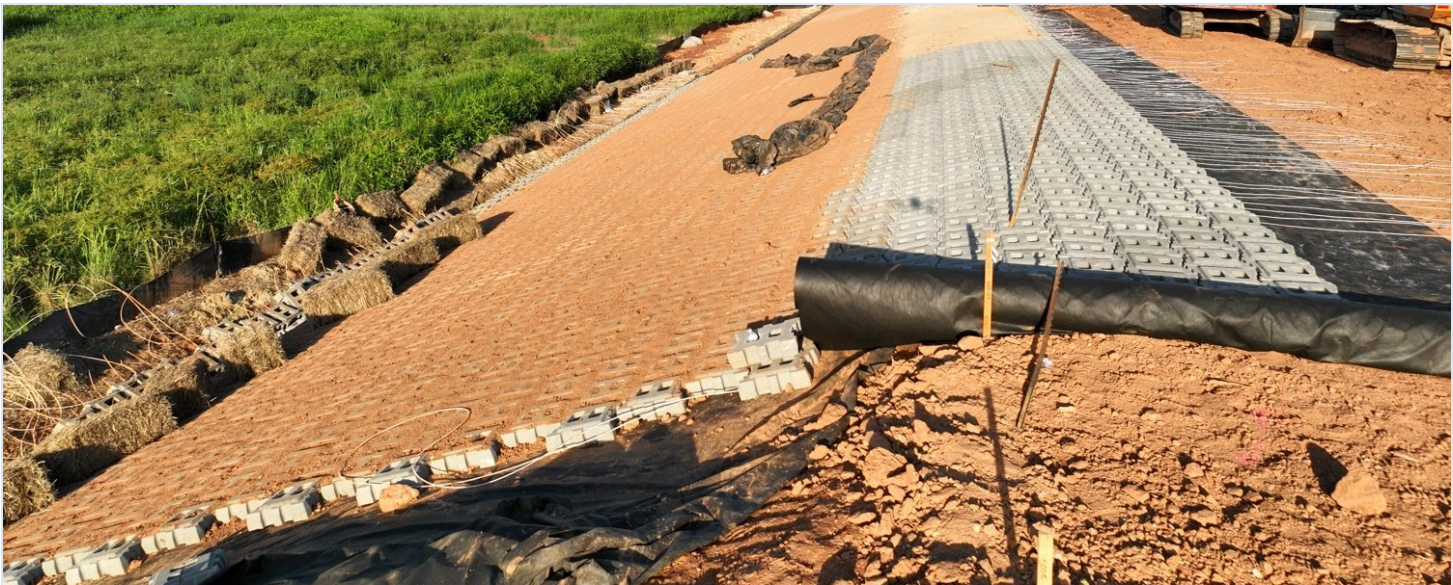
Fig. 1 — Site overview on the date of flight. Haul corridor, base placement and material staging in a single orienting frame.

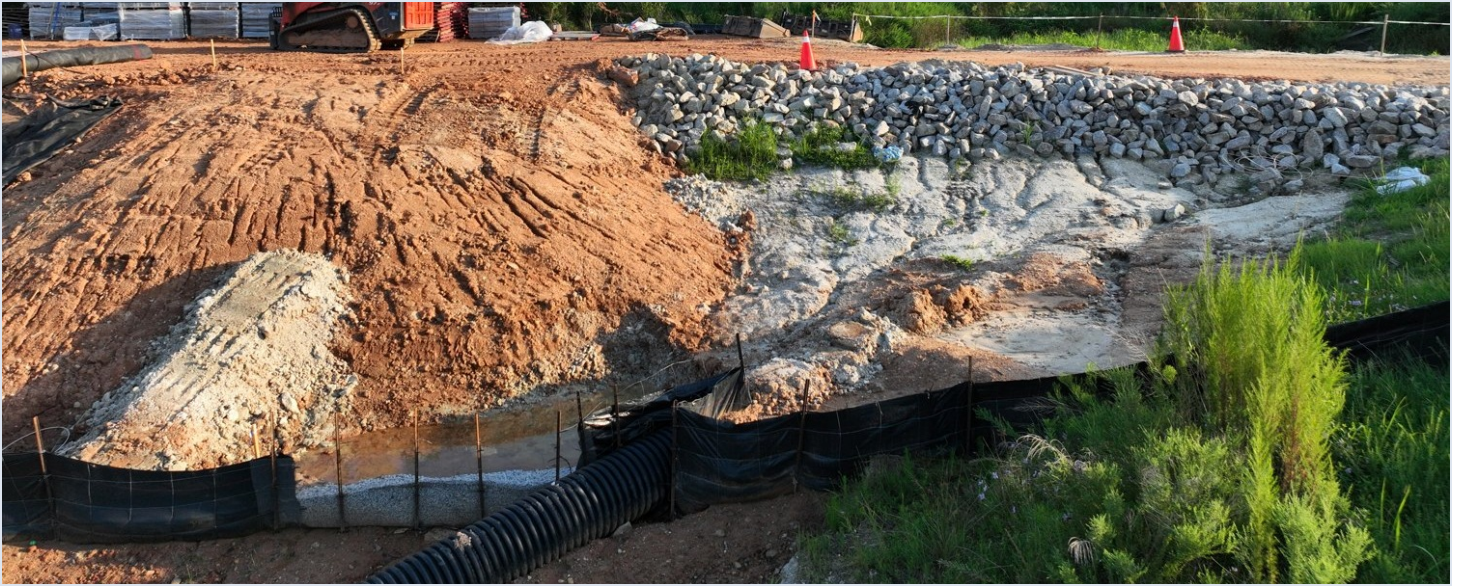
*Fig. 2 — Material stockpile and equipment staging on the date of flight.*

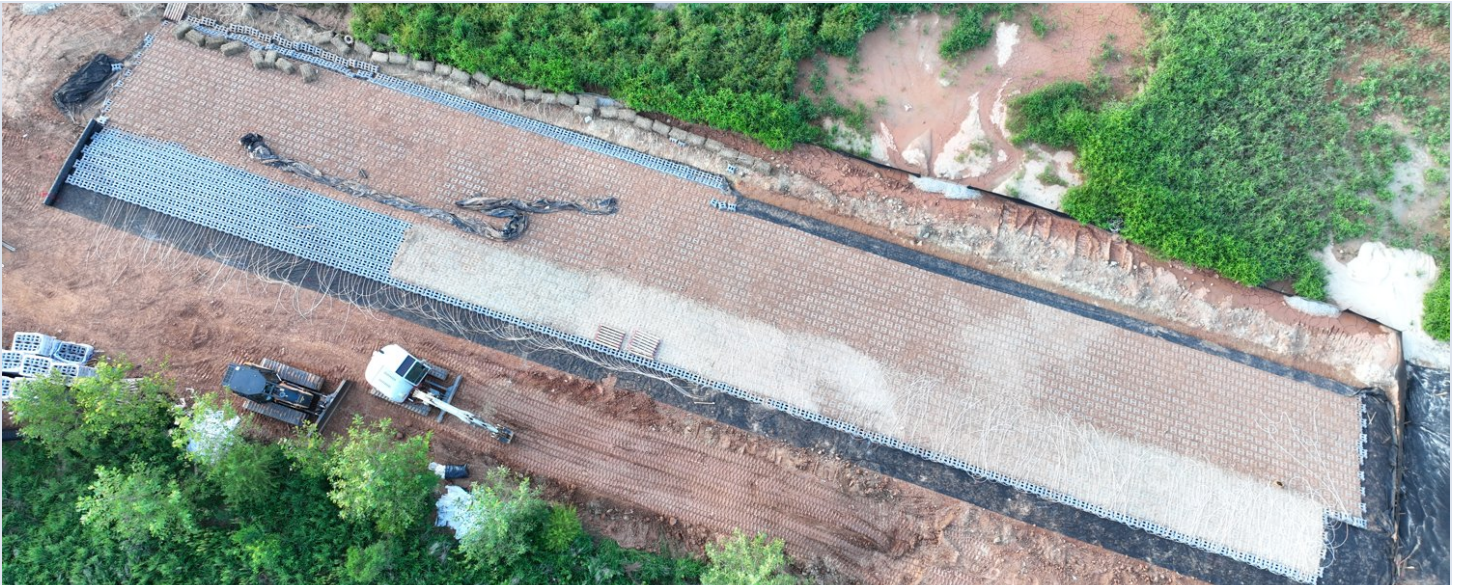
*Fig. 3 — Wall and structure placement; alignment and backfill state at capture.*

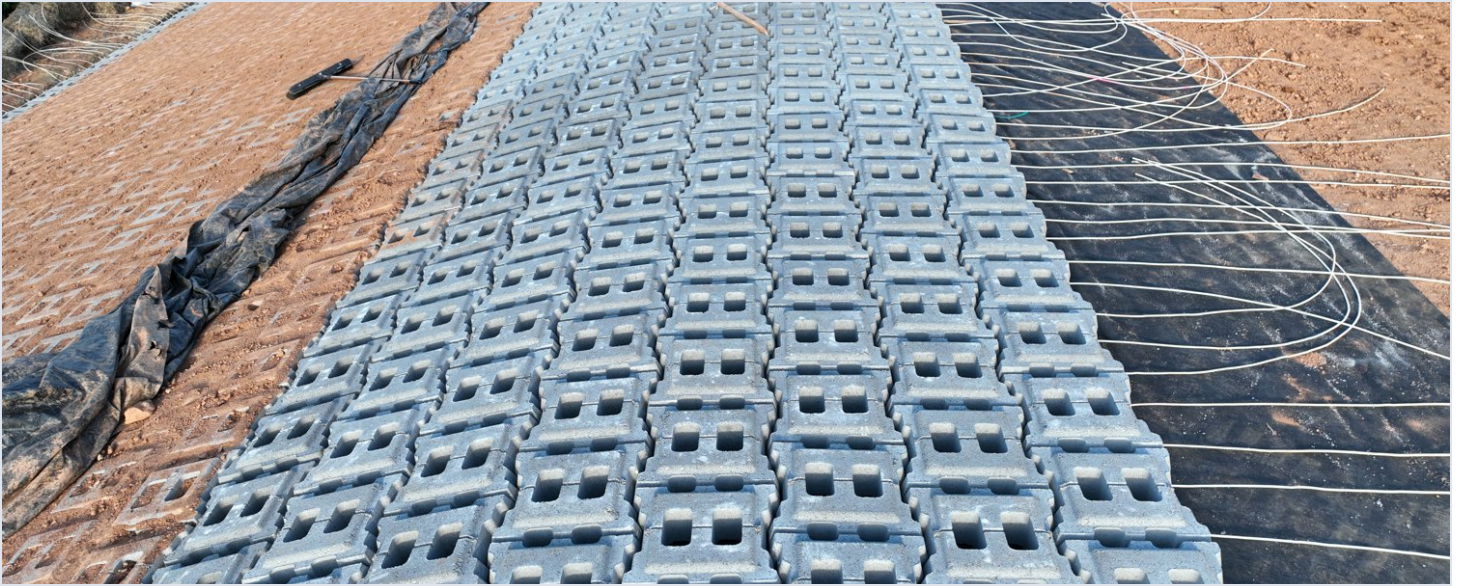
| LOCATION | OBSERVATION | SEVERITY |
|---|---|---|
| Base course, pre-cover | Geogrid and base placement photographed from directly overhead prior to cover — the layer that becomes unevidenced once the next lift is placed (Fig. 4) | LOW |

*Fig. 4 — Geogrid and base placement, photographed from directly overhead prior to cover.*

Retain this capture as the dated record for the work in place at this stage, particularly the pre-cover frames — geogrid, base and drainage structures are not evidenceable once covered. Repeat the same flight positions at the next milestone so two dates can be compared without argument about the angle. Where conformance or quantity is in question, refer to the engineer of record; this report records condition only.

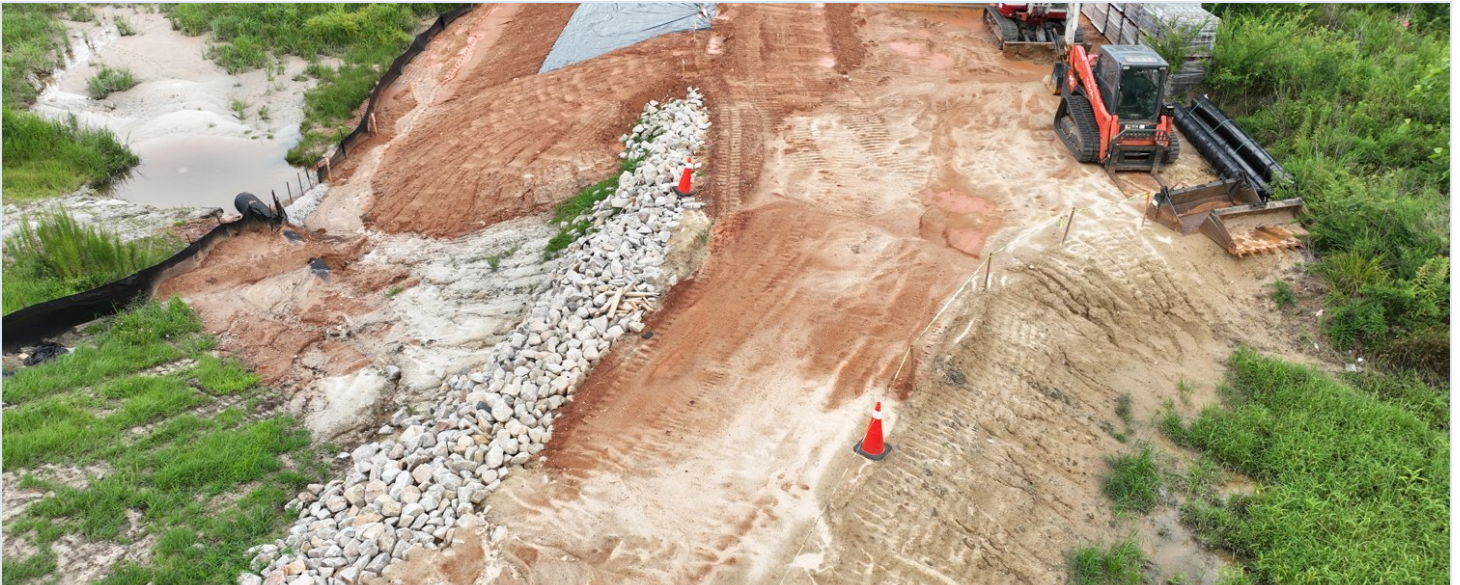
| LOCATION | OBSERVATION | SEVERITY |
|---|---|---|
| Drainage structures | Headwall, inlet and outlet protection recorded as installed, prior to cover (Figs. 5–7) | LOW |

*Fig. 5 — Headwall and inlet structure with surrounding grade, before cover.*

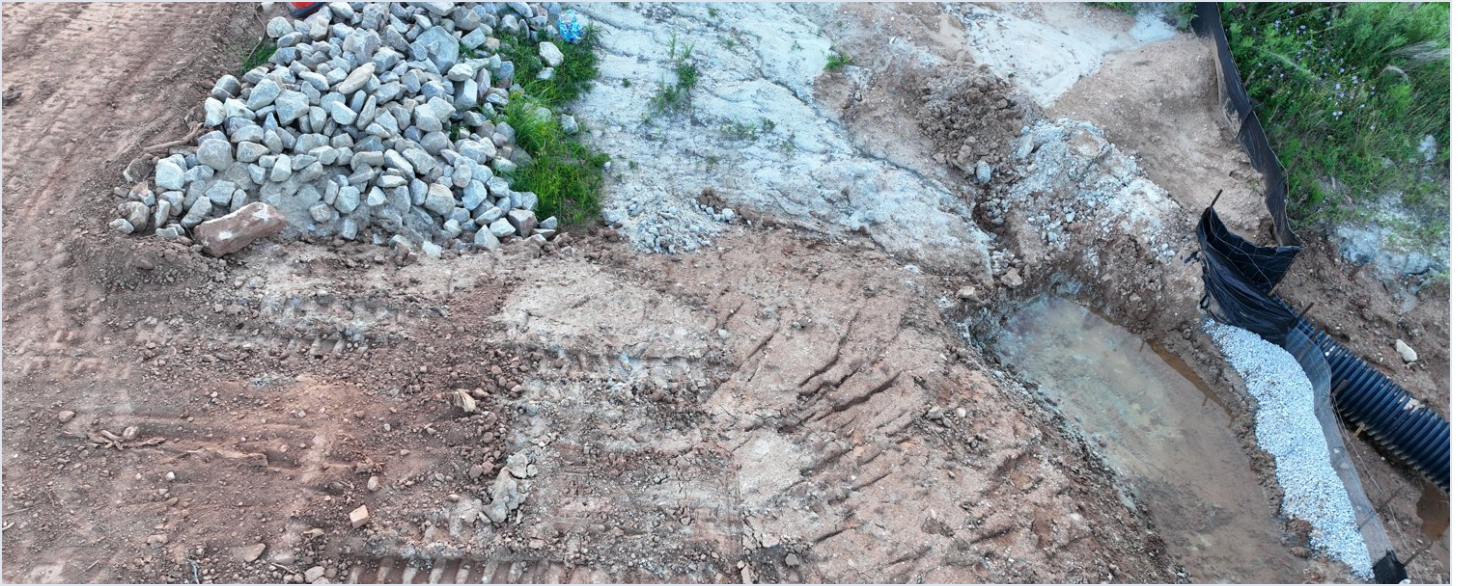
*Fig. 6 — Rip-rap apron and outlet protection as installed, at low altitude.*

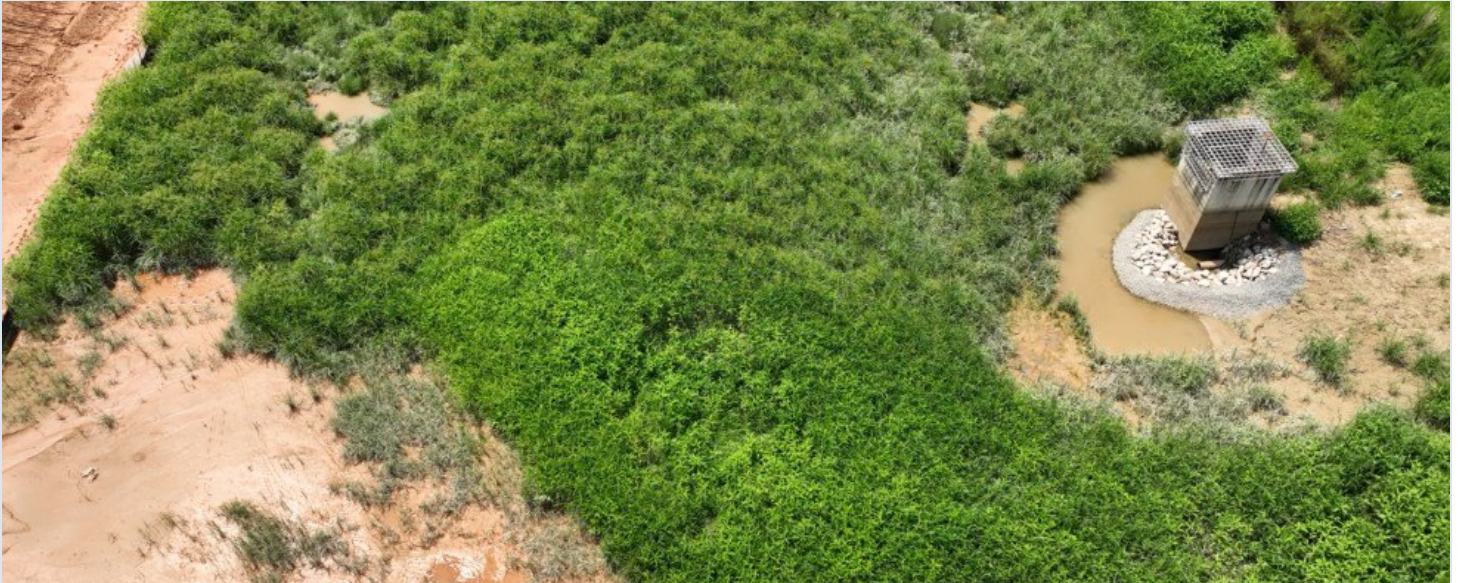
*Fig. 7 — Outlet channel; stone placement and channel section.*

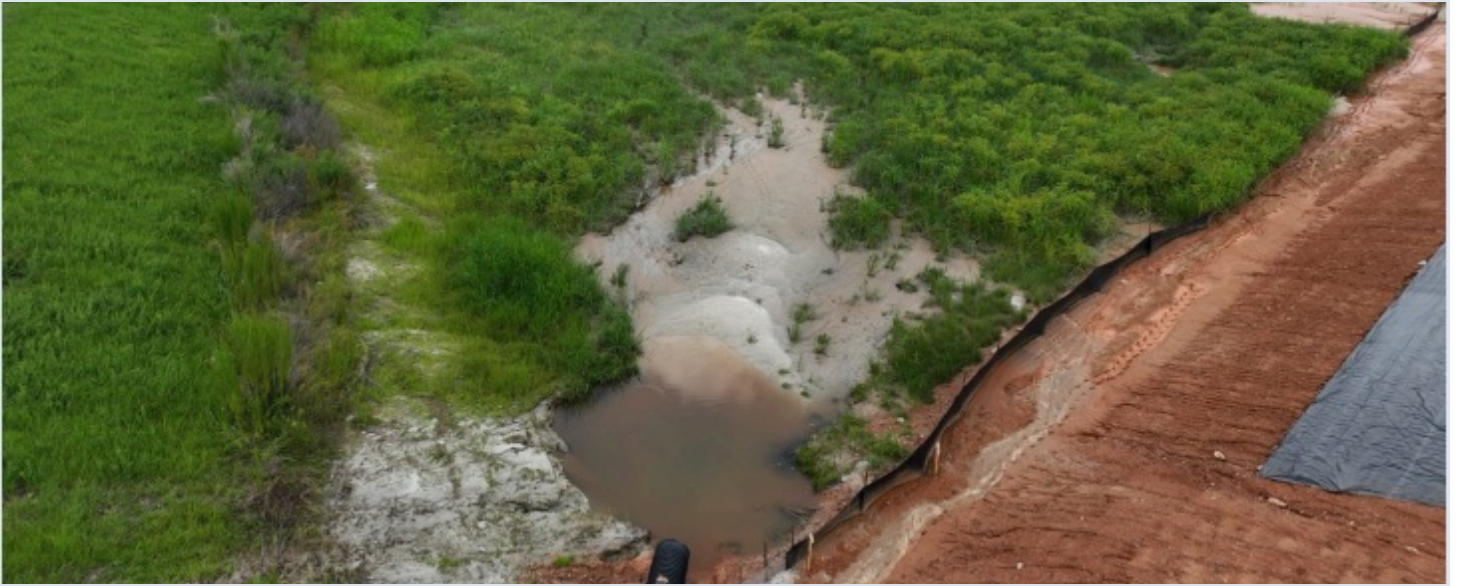
| LOCATION | OBSERVATION | SEVERITY |
|---|---|---|
| Sediment basin | Water level, vegetation establishment and berm condition after weather (Fig. 8) | LOW |

*Fig. 8 — Sediment basin. Water level, vegetation establishment and berm condition after weather.*

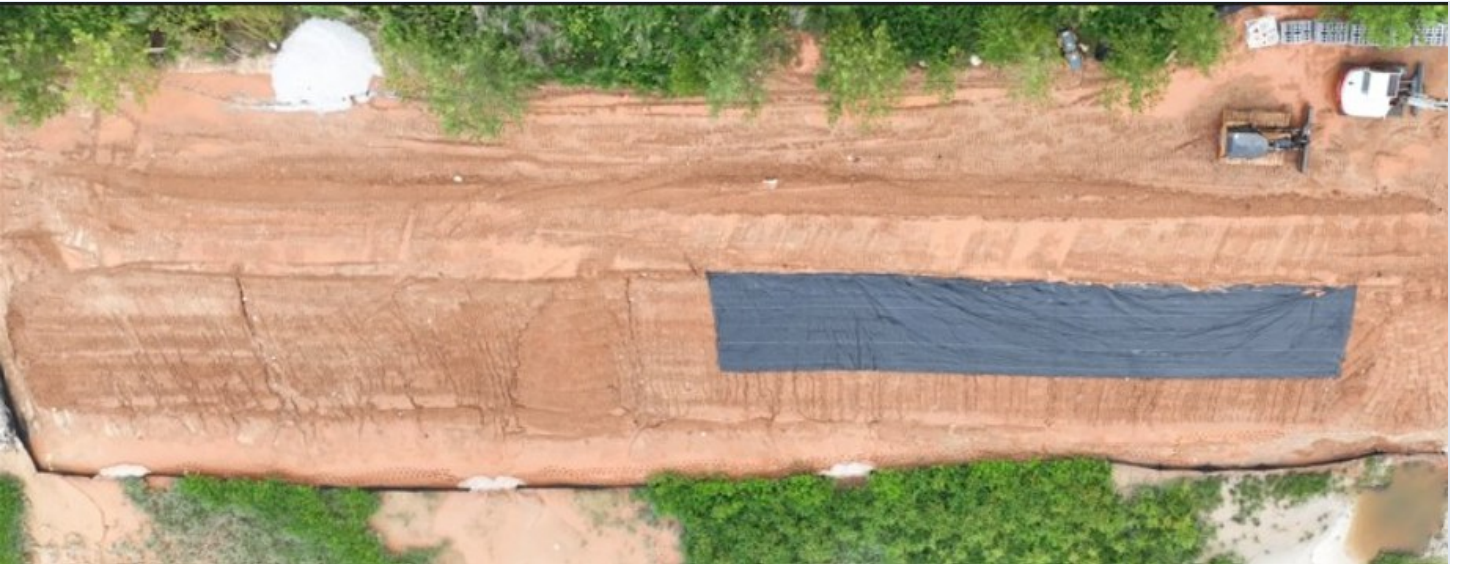
| LOCATION | OBSERVATION | SEVERITY |
|---|---|---|
| Haul corridor | Surface condition with standing water documented after rain; corridor passable, no rutting beyond surface water observed (Fig. 9) | LOW |

*Fig. 9 — Graded haul corridor; surface condition and standing water after rain.*

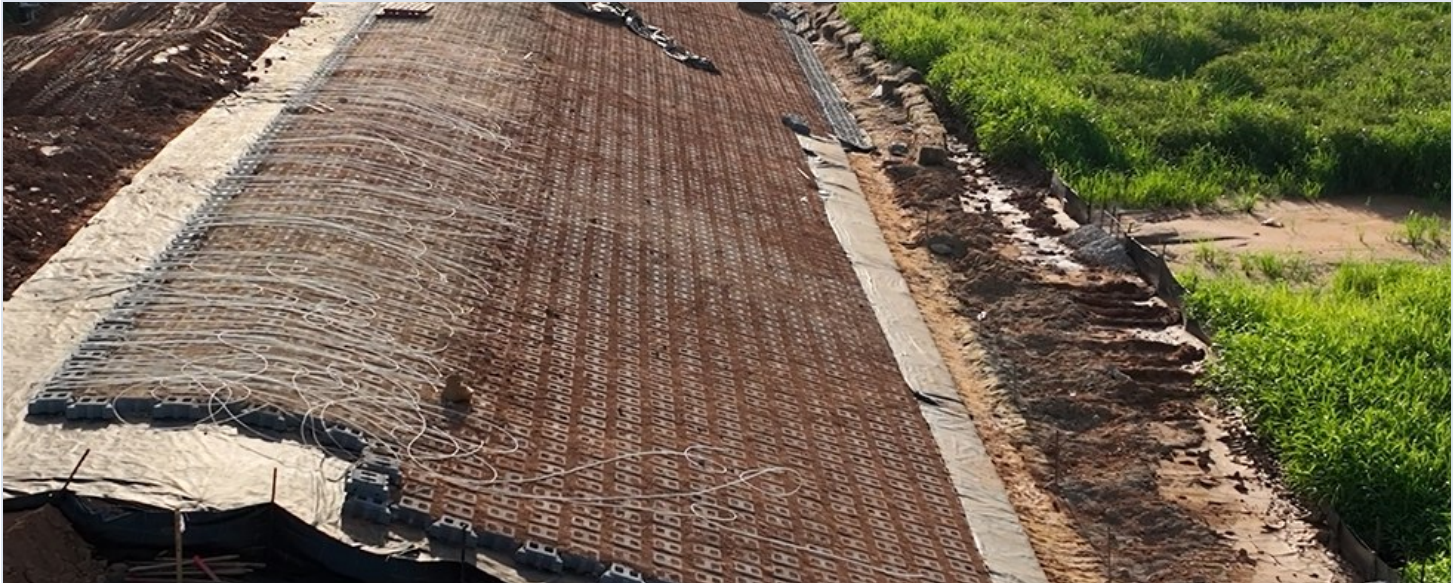
Fig. 10 — Near-nadir capture of the finished channel section, flown to a repeatable position for visit-to-visit comparison.
