# HOA COMMON-AREA SURVEY

Association common areas · amenity buildings, turf, stormwater and access · capture date withheld

| <b>Community</b> | Address withheld | <b>Report ID</b> | MWA-SMP-0005 |

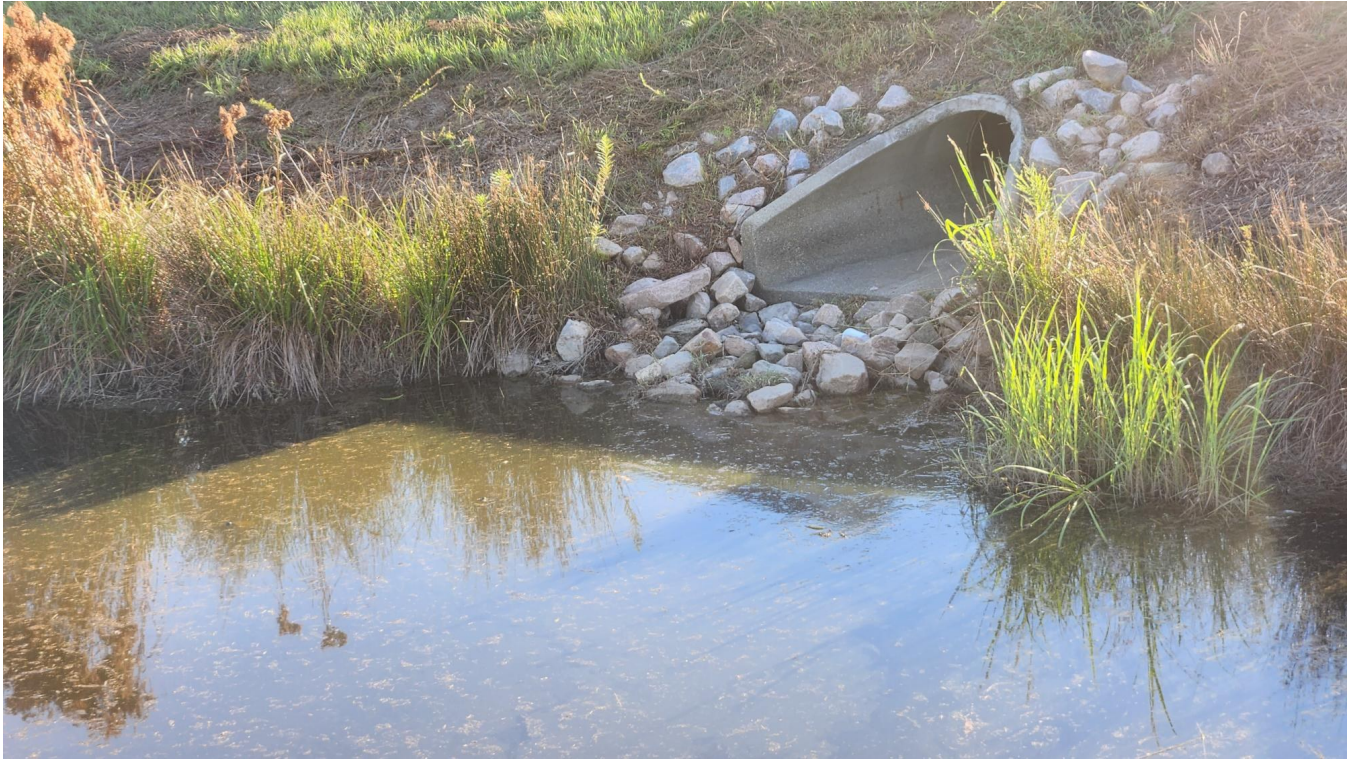
*Fig. 1 — Stormwater control measure outfall. Reinforced concrete pipe with riprap stone apron discharging to the permitted pond. Riprap coverage extends approximately eight feet from pipe outlet; grass cover along bank established, no debris blocking outlet.*

Reinforced concrete outfall pipe with riprap stone apron discharging to permitted stormwater pond. Riprap coverage extends approximately eight feet from pipe outlet; some displacement of smaller stones toward the downstream edge is visible. Grass cover along the pond bank is established. Water level at capture sits within the normal operating range for the pond. Sediment accumulation at the base of the riprap is minor and consistent with routine seasonal conditions. No debris blocking the outlet.

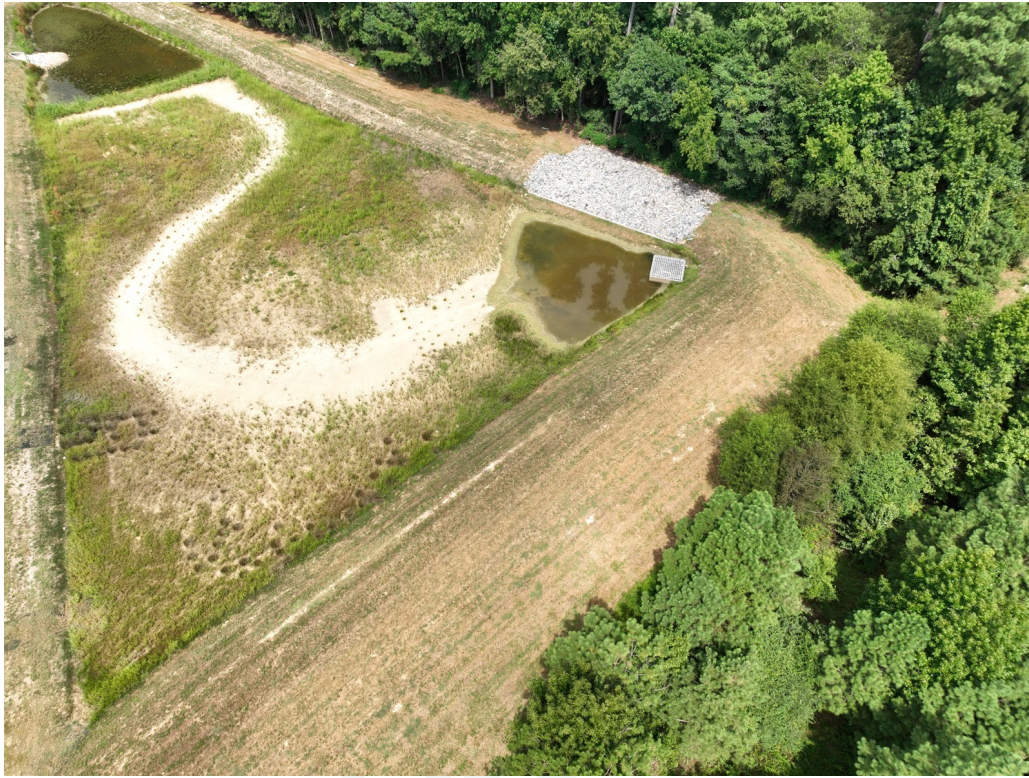
| LOCATION | OBSERVATION | SEVERITY |
|---|---|---|
| <b>Stormwater control measure</b> | Sediment accumulation across the forebay, surface dry and exposed on date of flight. Outlet structure and grate clear; rip-rap emergency spillway in place. (Figs. 1–2) | <b>MEDIUM</b> |

*Fig. 2 — Stormwater control measure aerial view: forebay with sediment accumulation, permanent pool, outlet structure and rip-rap emergency spillway.*

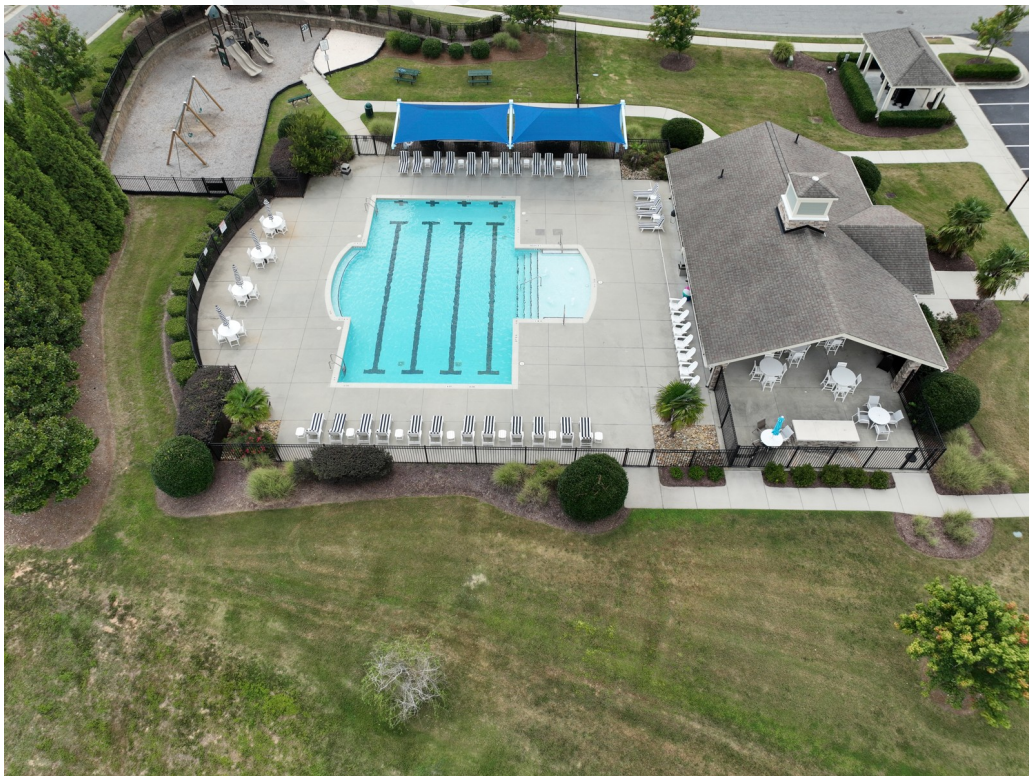
| LOCATION | OBSERVATION | SEVERITY |
|---|---|---|
| <b>Amenity center and pool deck</b> | Roof, shade structures, deck, perimeter fencing and furniture recorded as found; no displaced material or standing water observed. (Figs. 3–4) | <b>LOW</b> |

*Fig. 3 — Amenity center and pool deck on the date of flight. Roof, shade structures, deck, perimeter fencing and furniture in a single orienting frame.*

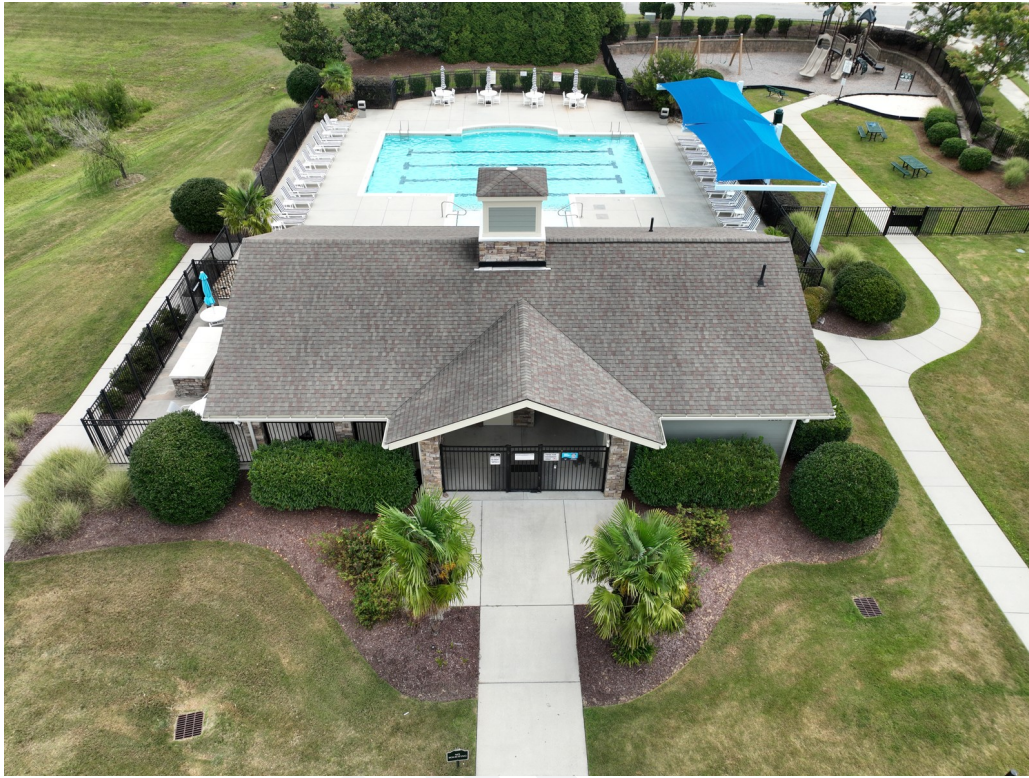
Fig. 4 — Pool enclosure and clubhouse approach; deck surface, walkway and landscape beds.

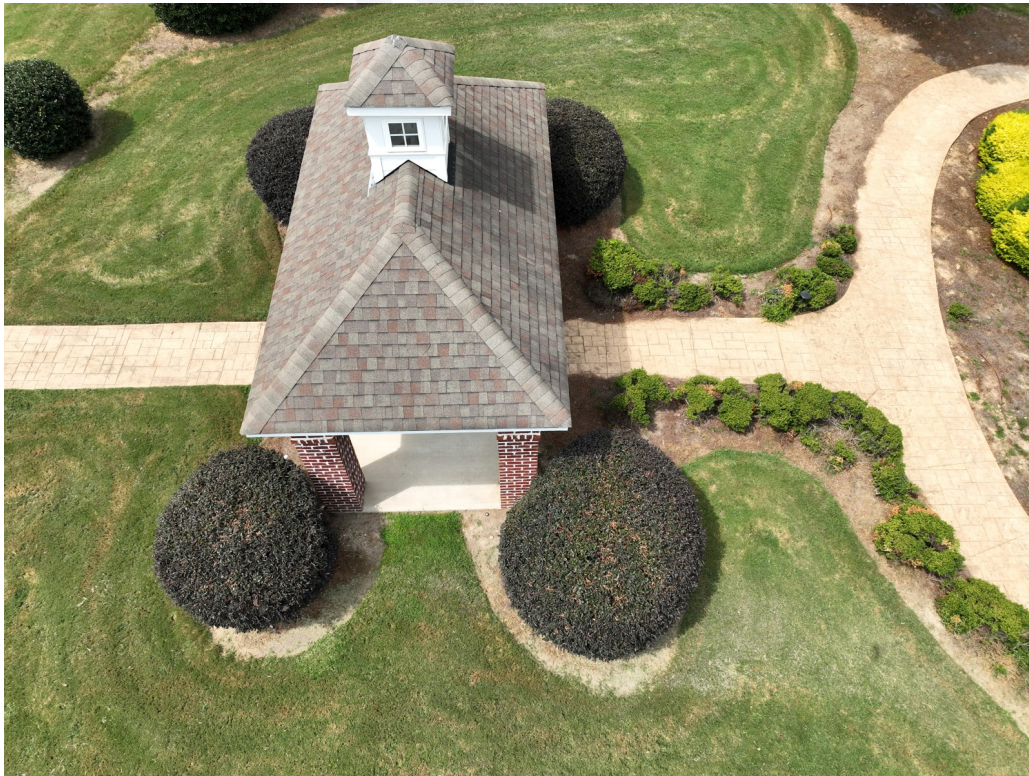
| LOCATION | OBSERVATION | SEVERITY |
|---|---|---|
| <b>Pavilion</b> | Roof, columns and surrounding walkway and beds recorded overhead for the reserve file. (Fig. 5) | <b>LOW</b> |

Fig. 5 — Picnic pavilion, photographed from directly overhead; roof surface, walkway and surrounding beds.

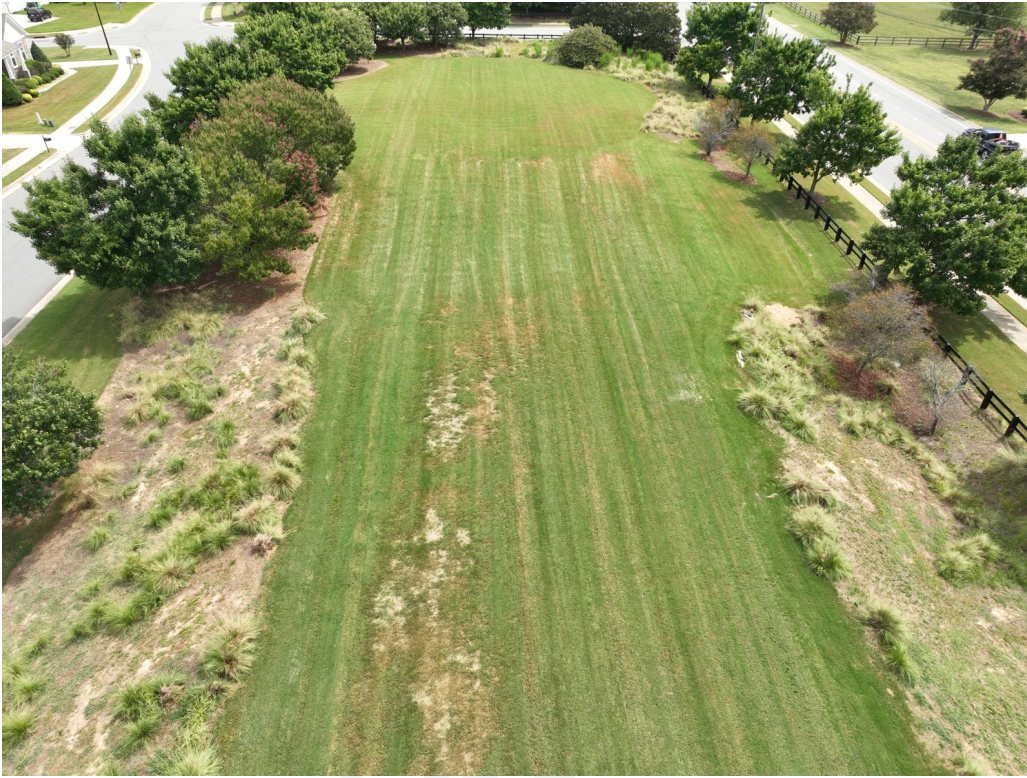
| LOCATION | OBSERVATION | SEVERITY |
|---|---|---|
| <b>Common turf</b> | Bare and thinning patches across central maintained area, mower striping visible, established edge planting on both banks. (Figs. 6–7) | <b>MEDIUM</b> |

*Fig. 6 — Common turf area. Bare and thinning patches across the central maintained section, with established edge planting on both banks.*

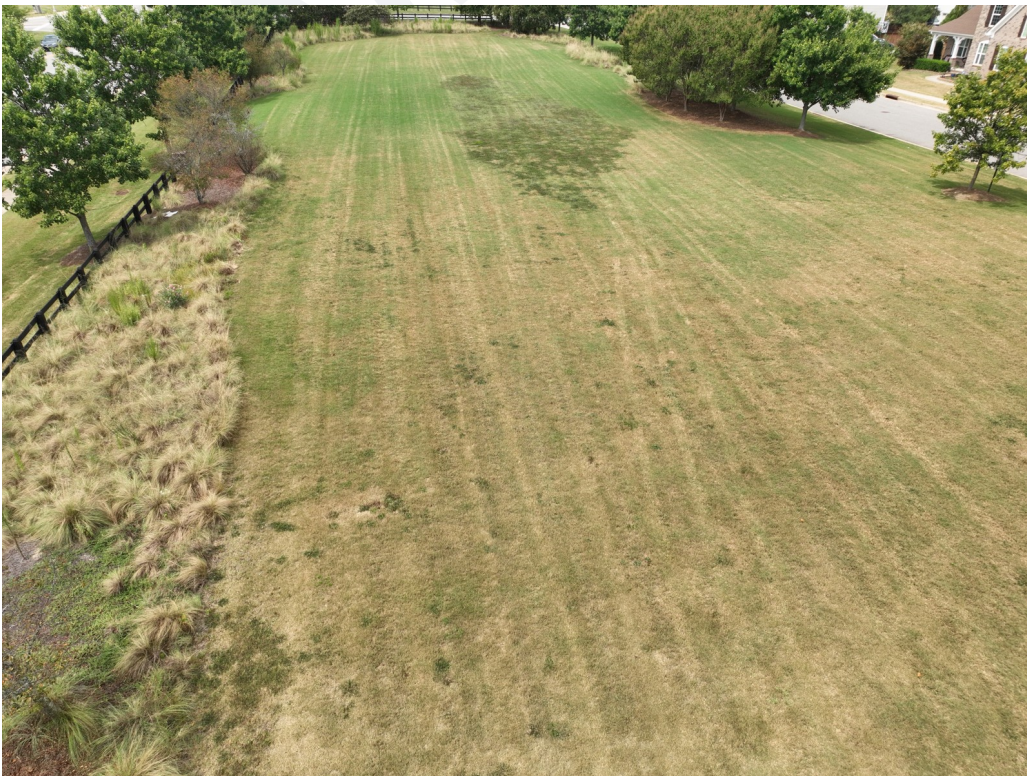
*Fig. 7 — Second common turf area; mown surface condition and tree line at the boundary.*

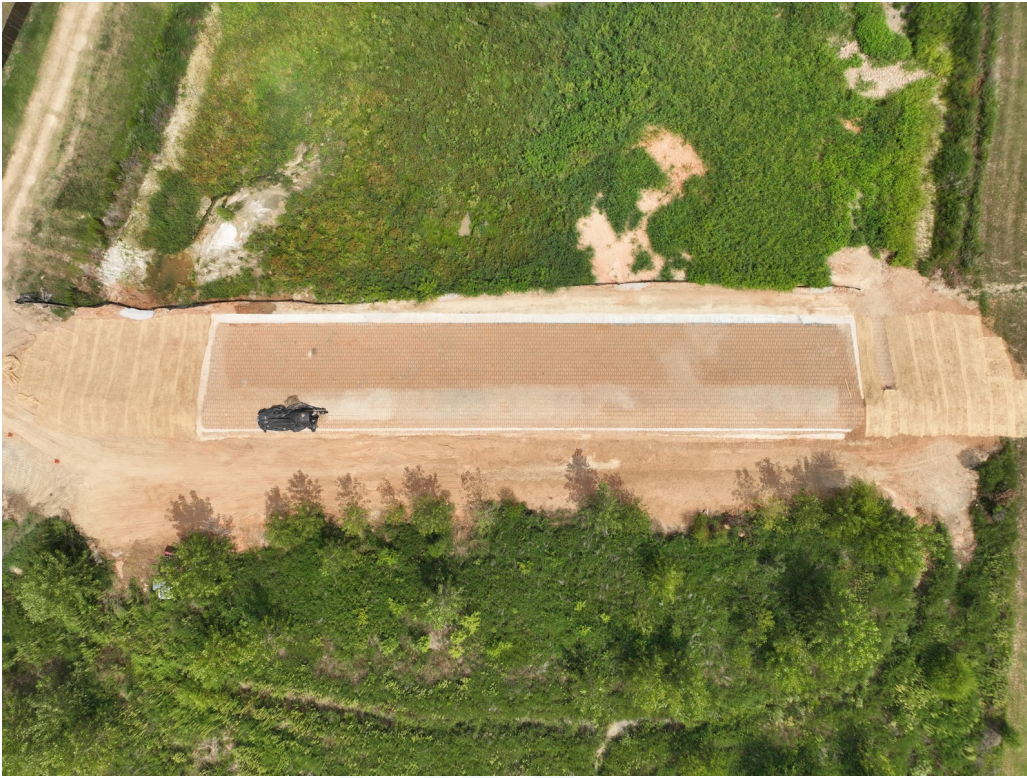
| LOCATION | OBSERVATION | SEVERITY |
|---|---|---|
| Maintained path | Graded section with unsurfaced running surface and defined shoulders. (Fig. 8) | LOW |

Fig. 8 — Maintained path; graded running surface and defined shoulders.

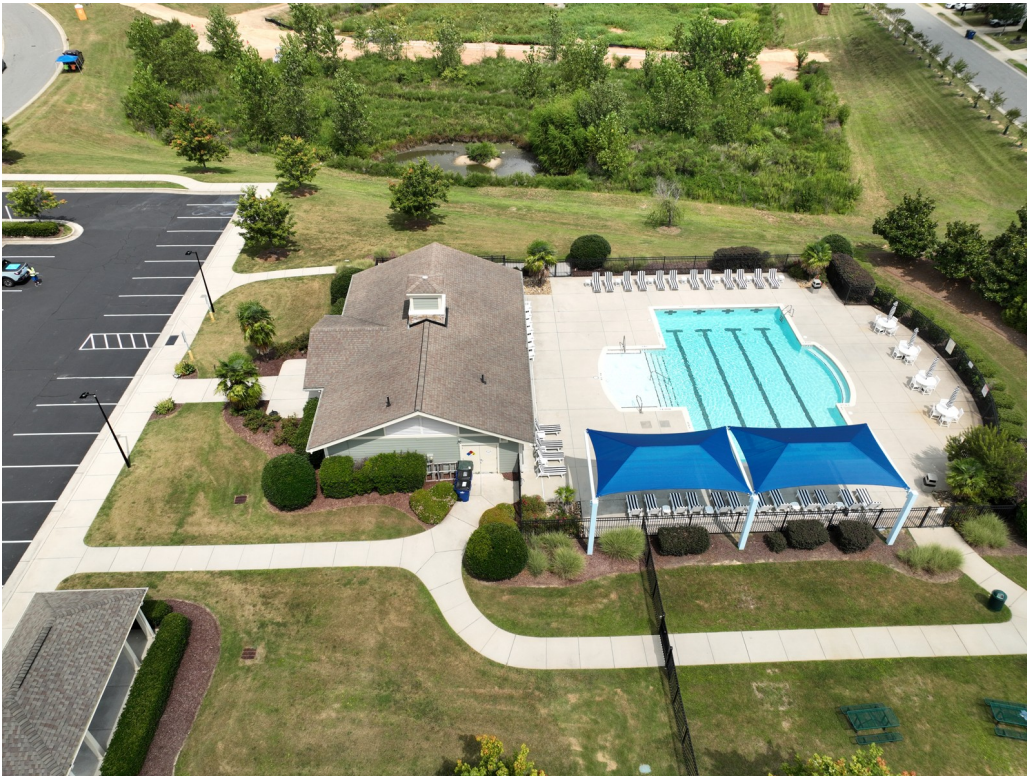
| LOCATION | OBSERVATION | SEVERITY |
|---|---|---|
| Access drive and parking | Surface, striping and curb line recorded; no ponding visible. (Fig. 9) | LOW |

Fig. 9 — Access drive and parking serving the amenity center; surface, striping and curb line.
