## INSURANCE SUPPORT PACKAGE

Per-slope evidence package for adjuster review · single-family residence · capture date withheld

| <b>Property</b> | Single-family residence · address withheld | <b>Report ID</b> | MWA-SMP-0006 |
| <b>Structure</b> | Hip-and-gable roof, architectural asphalt shingle | <b>Loss type</b> | Wind — cause not determined here |

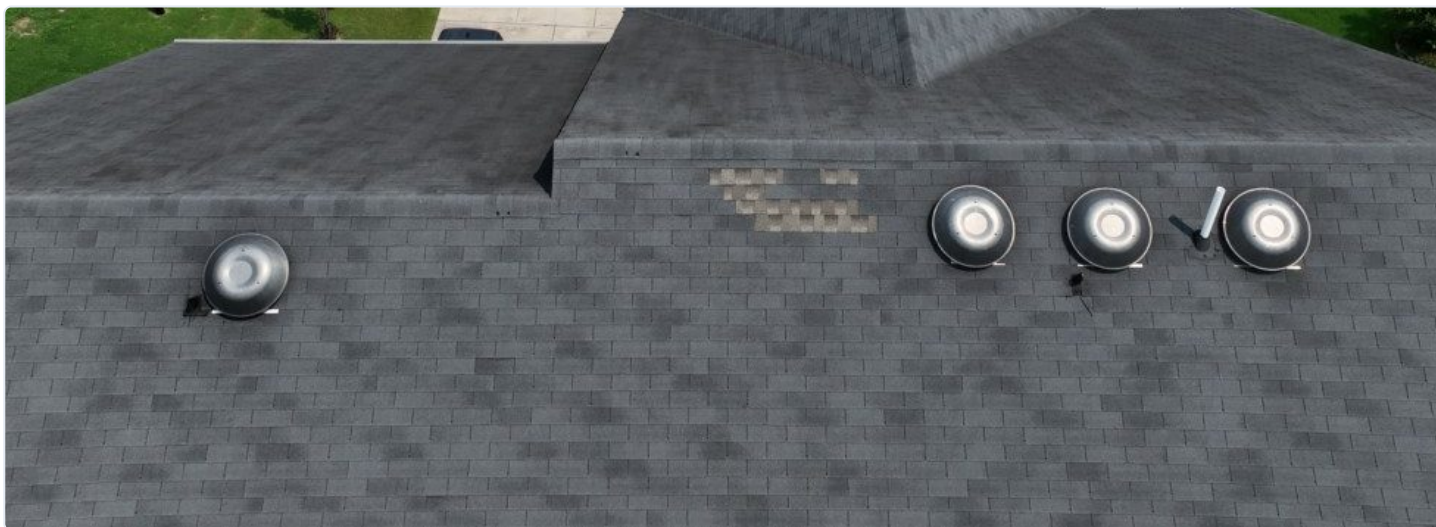
| LOCATION | OBSERVATION | SEVERITY |
|---|---|---|
| P1 — front (south), upper ridge | Approximately 10 shingles missing with underlayment exposed across the affected courses. Surrounding field intact; no impact bruising observed on this plane (Figs. 2–4) | HIGH |

Fig. 2 — P1 front plane in context. Affected area sits immediately below the ridge; surrounding field, vents and ridge line intact.

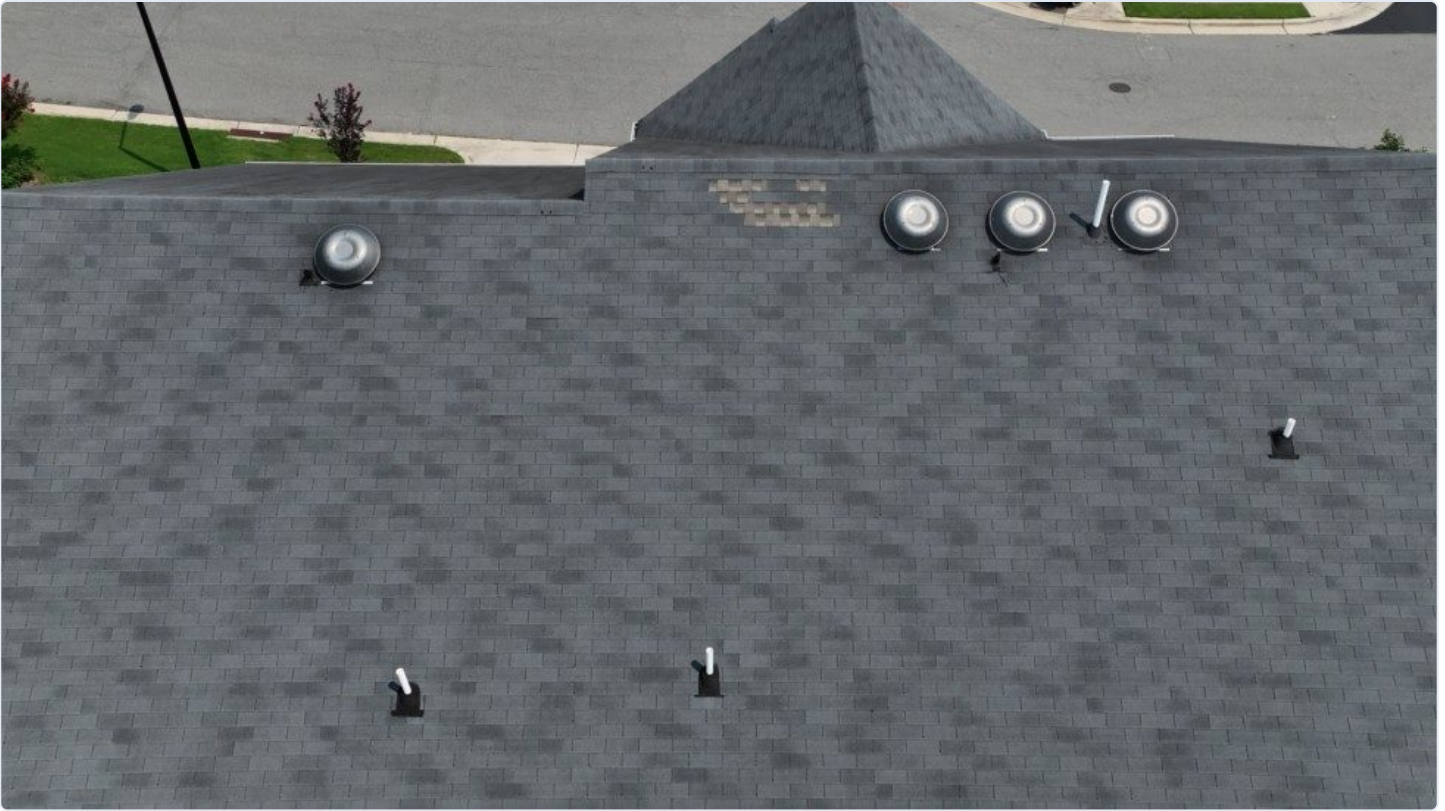
*Fig. 3 — P1 — missing shingles along the upper ridge, underlayment exposed across the affected courses.*

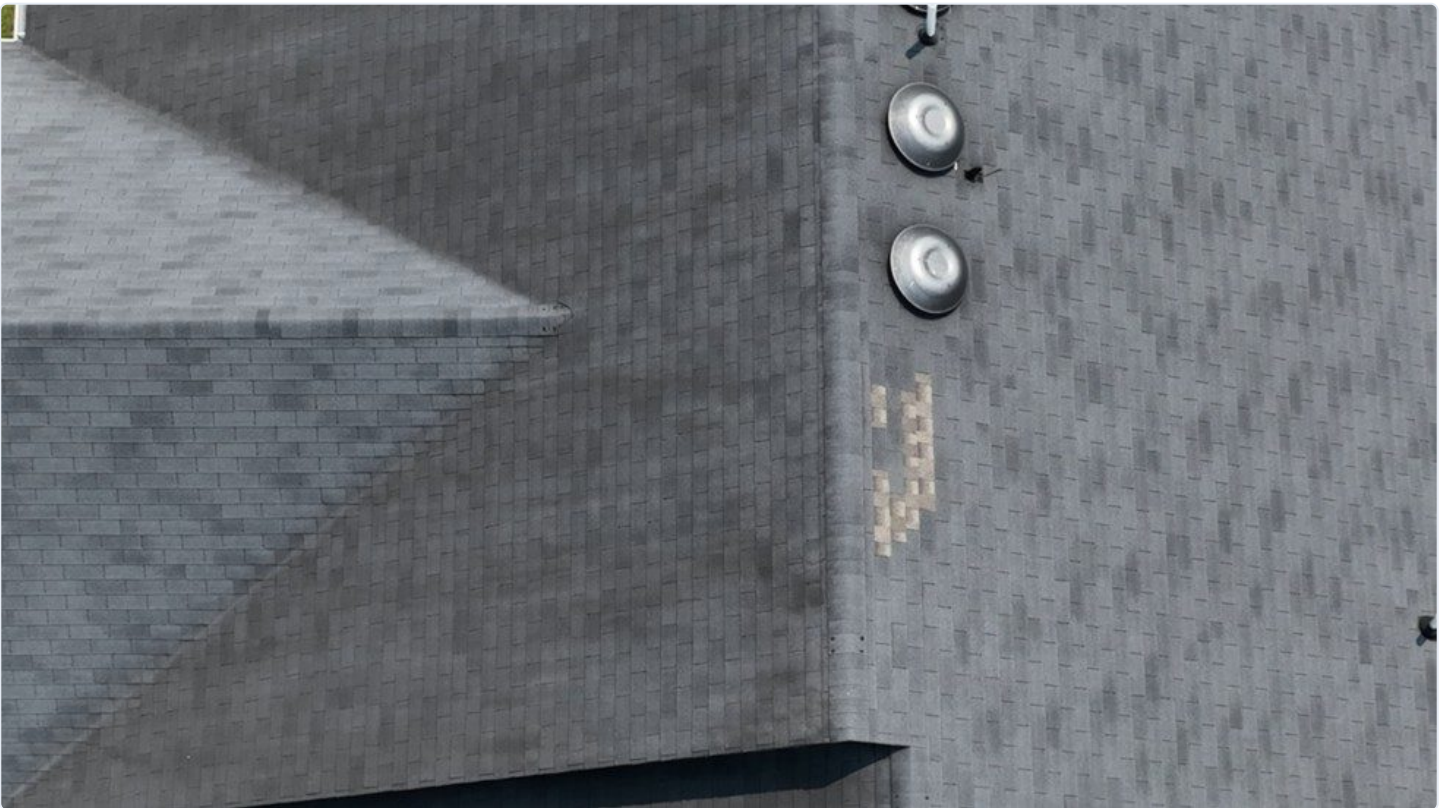
*Fig. 4 — P1 — the same finding from the opposing approach. Two angles on one defect.*

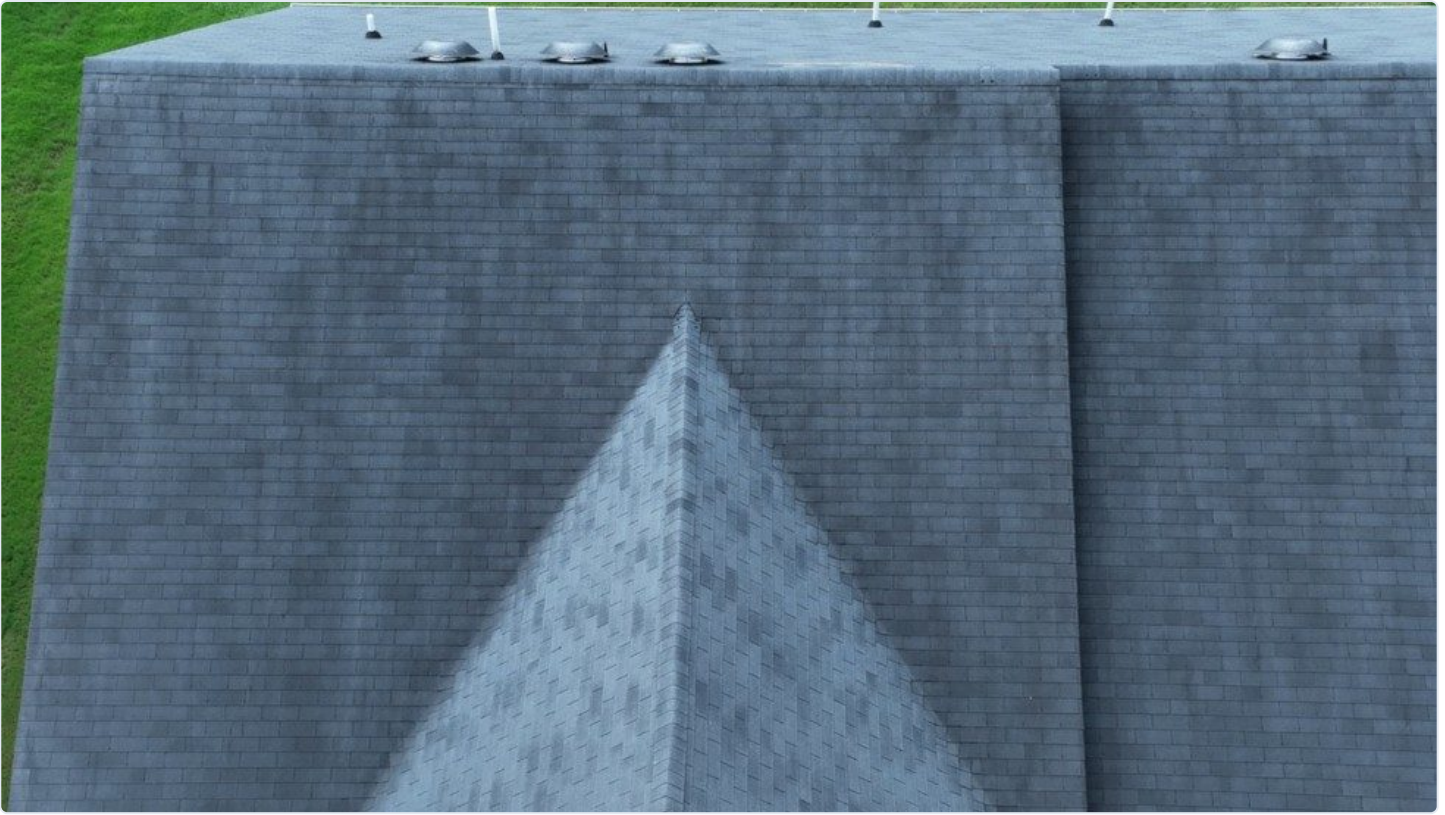
| LOCATION | OBSERVATION | SEVERITY |
|---|---|---|
| P2 and P4 — right and left | Captured at matched altitude and heading for comparison against P1. Uniform shingle field; no missing material observed (Fig. 5) | LOW |

*Fig. 5 — P2 — adjacent plane and hip transition at matched altitude. Uniform shingle field, no missing material.*

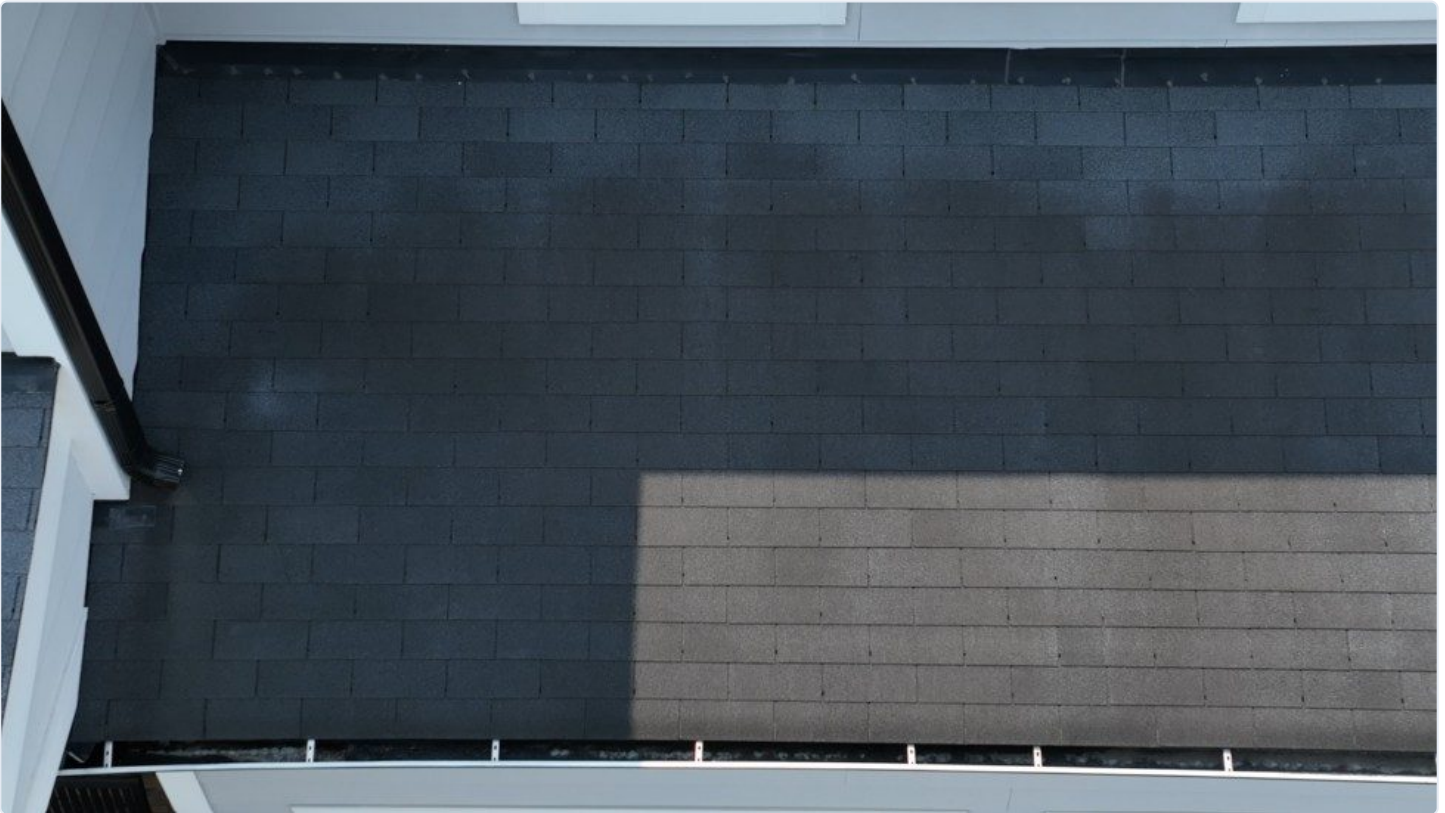
| LOCATION | OBSERVATION | SEVERITY |
|---|---|---|
| P3 — rear (north), valley transition | Localized surface discoloration near the valley; cause and depth of any material change not determinable at this resolution (Fig. 6) | LOW |

*Fig. 6 — P3 — valley transition and gutter line. Localized surface discoloration recorded as a LOW observation.*

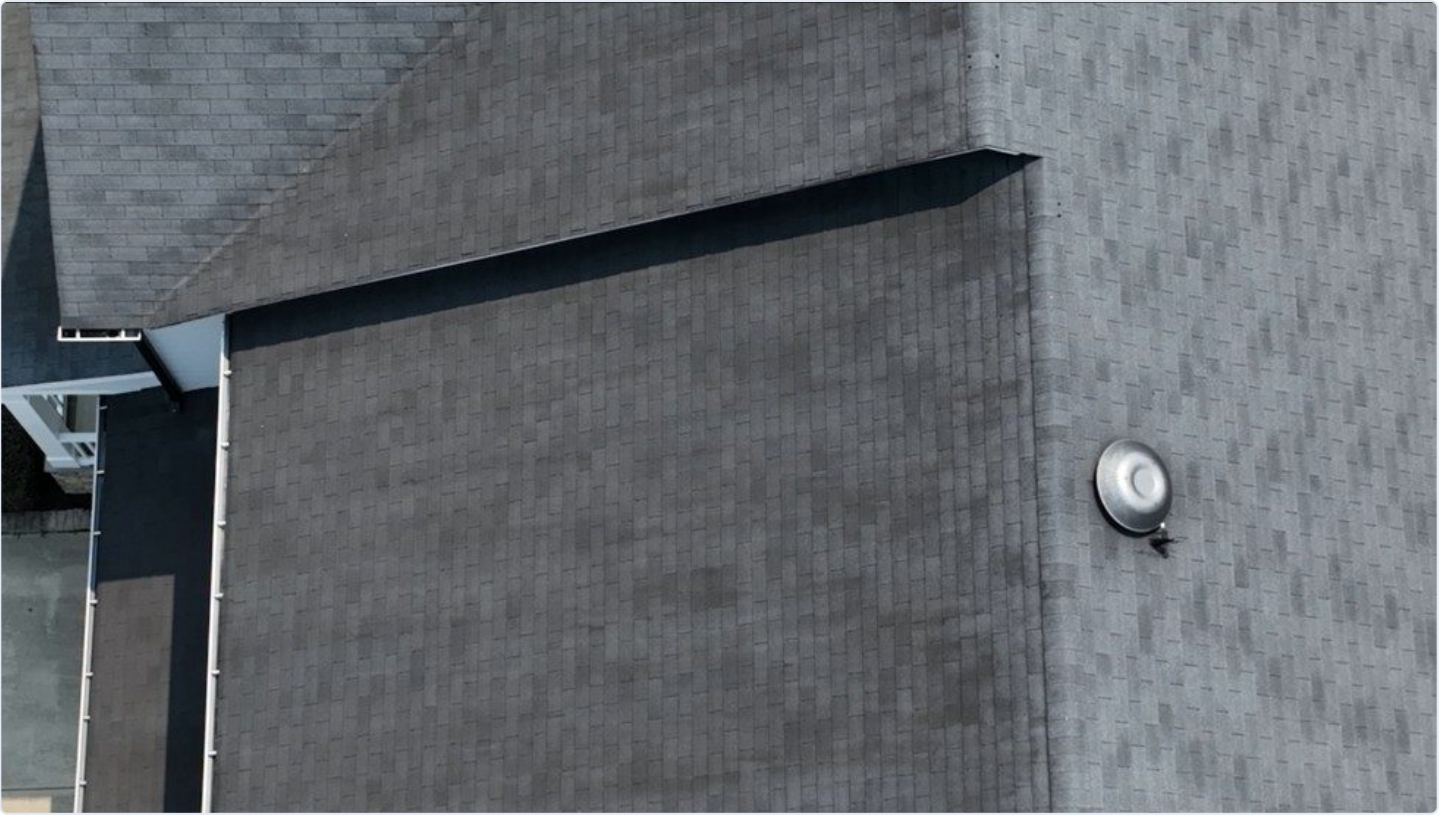
| LOCATION | OBSERVATION | SEVERITY |
|---|---|---|
| Perimeter and soft metal | Drip edge, gutter, rake, fascia and vent cluster captured separately; vents seated, no displacement observed (Fig. 7) | LOW |

Fig. 7 — Perimeter and vent cluster. Vents seated; no displacement observed.
