## LAND & SITE INTELLIGENCE REPORT

Property documentation · extent, access, drainage and erosion control · capture date withheld

| <b>Property</b> | Parcel address withheld | <b>Report ID</b> | MWA-SMP-0005 |

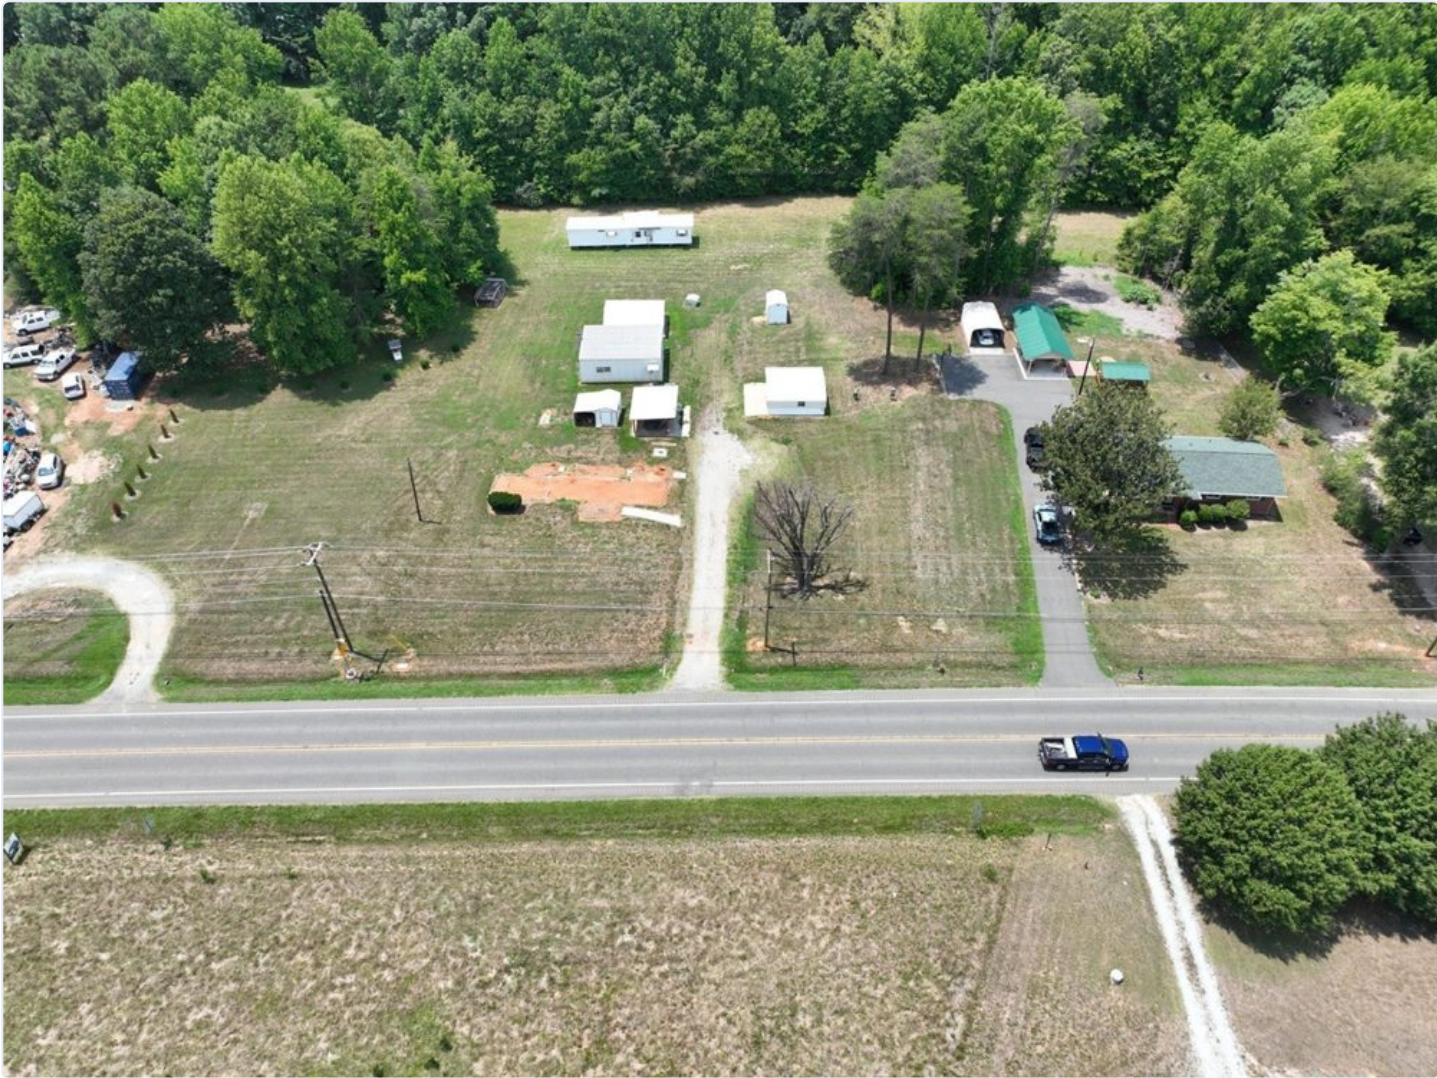
Fig. 1 — Oblique overview. Structures, road frontage and tree lines in a single frame.

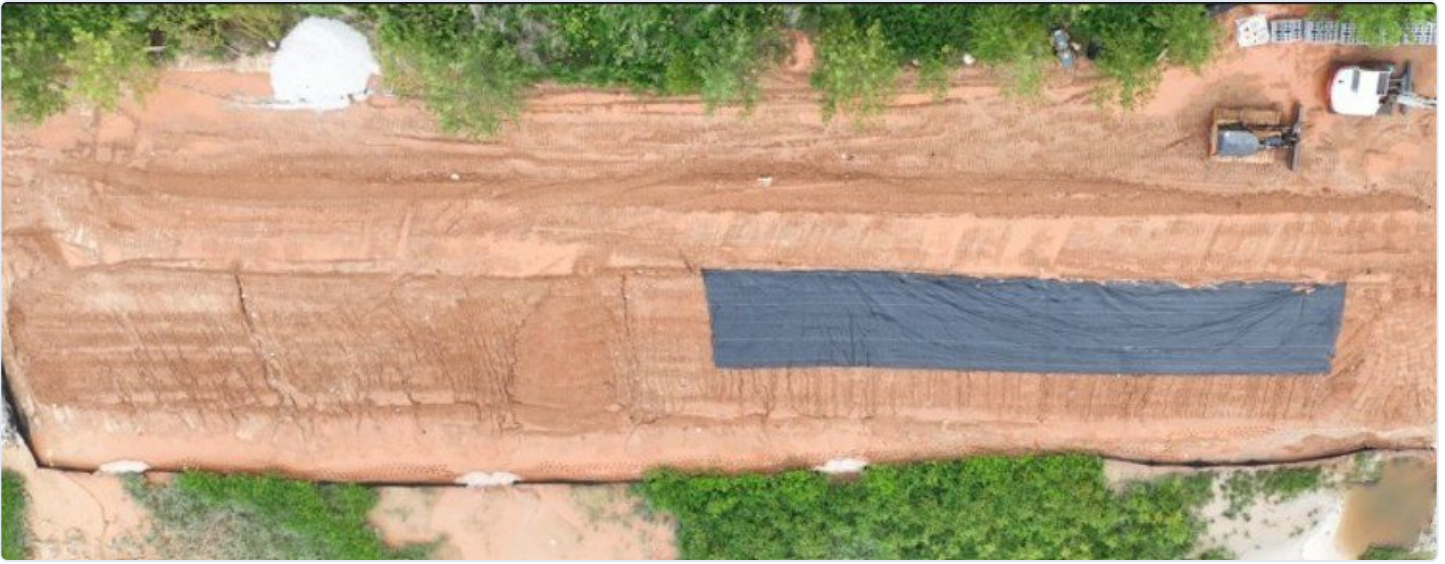
*Fig. 2 — Plan (near-nadir) view. Graded corridor and culvert crossing, photographed vertically so the same frame can be repeated on every visit.*

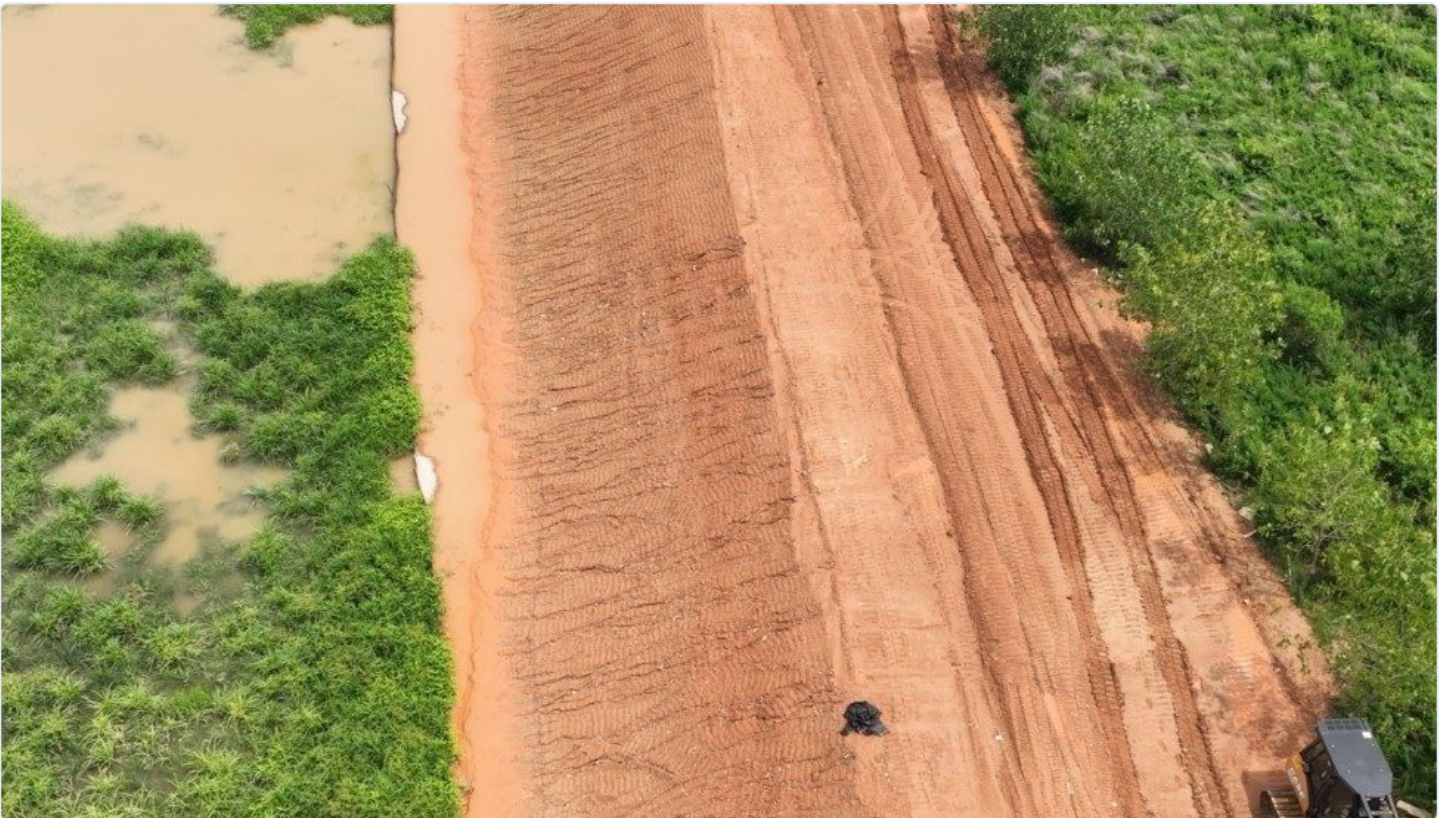
| LOCATION | OBSERVATION | SEVERITY |
|---|---|---|
| Entrance corridor | Graded surface with standing water documented after weather (Fig. 3) | LOW |

*Fig. 3 — Graded entrance corridor. Surface condition and standing water documented after weather.*

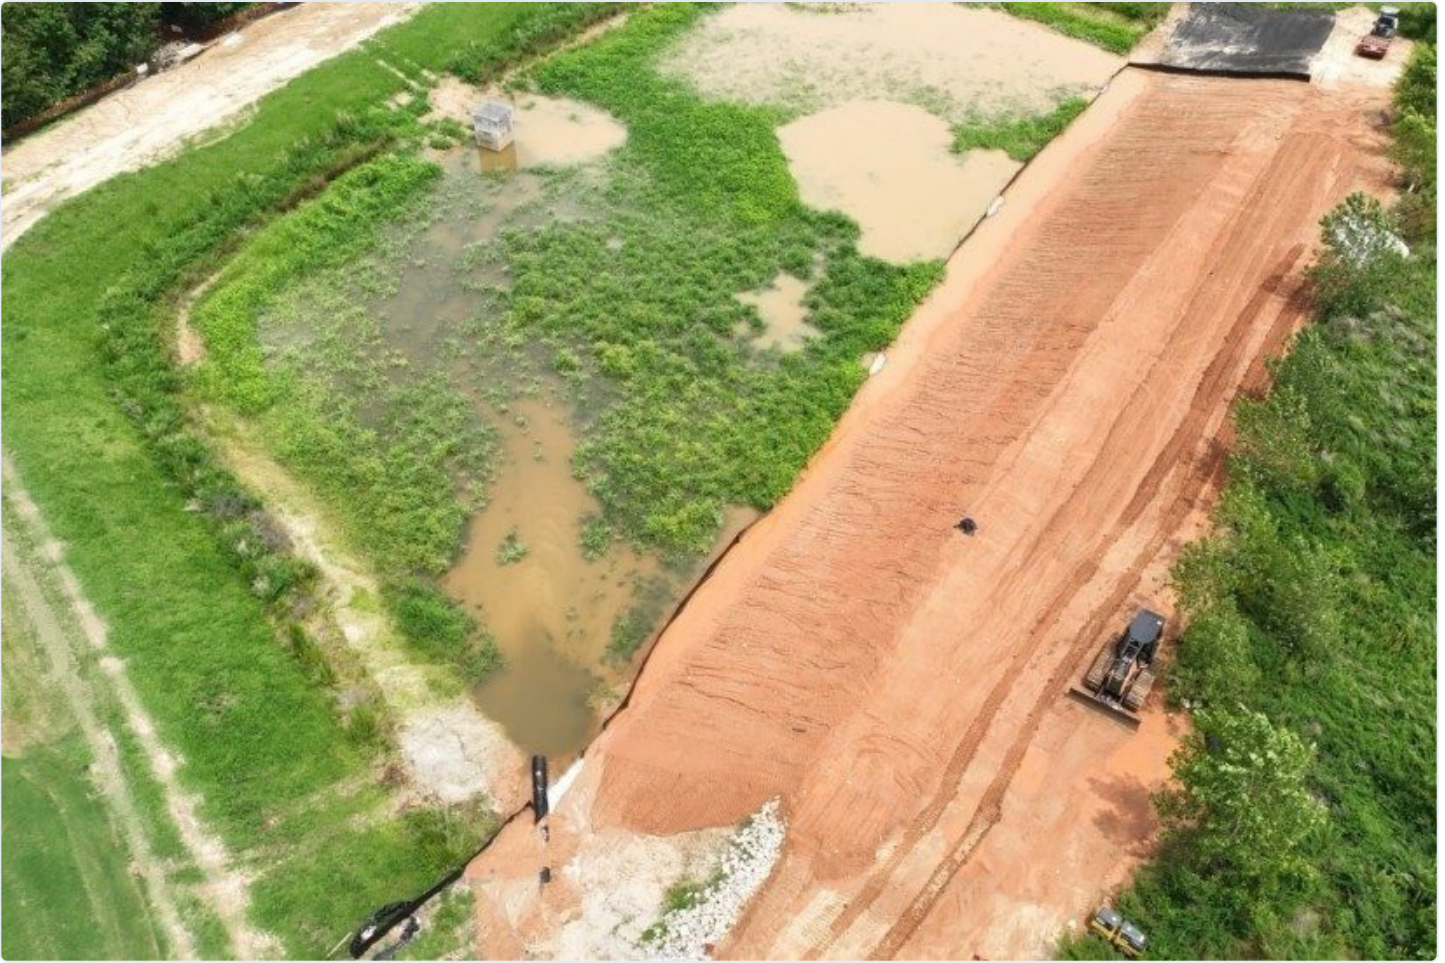
| LOCATION | OBSERVATION | SEVERITY |
|---|---|---|
| Retention area | Water level and vegetation state on the date of flight (Fig. 4) | LOW |

*Fig. 4 — Retention area and berm. Water level and vegetation state on the date of flight.*

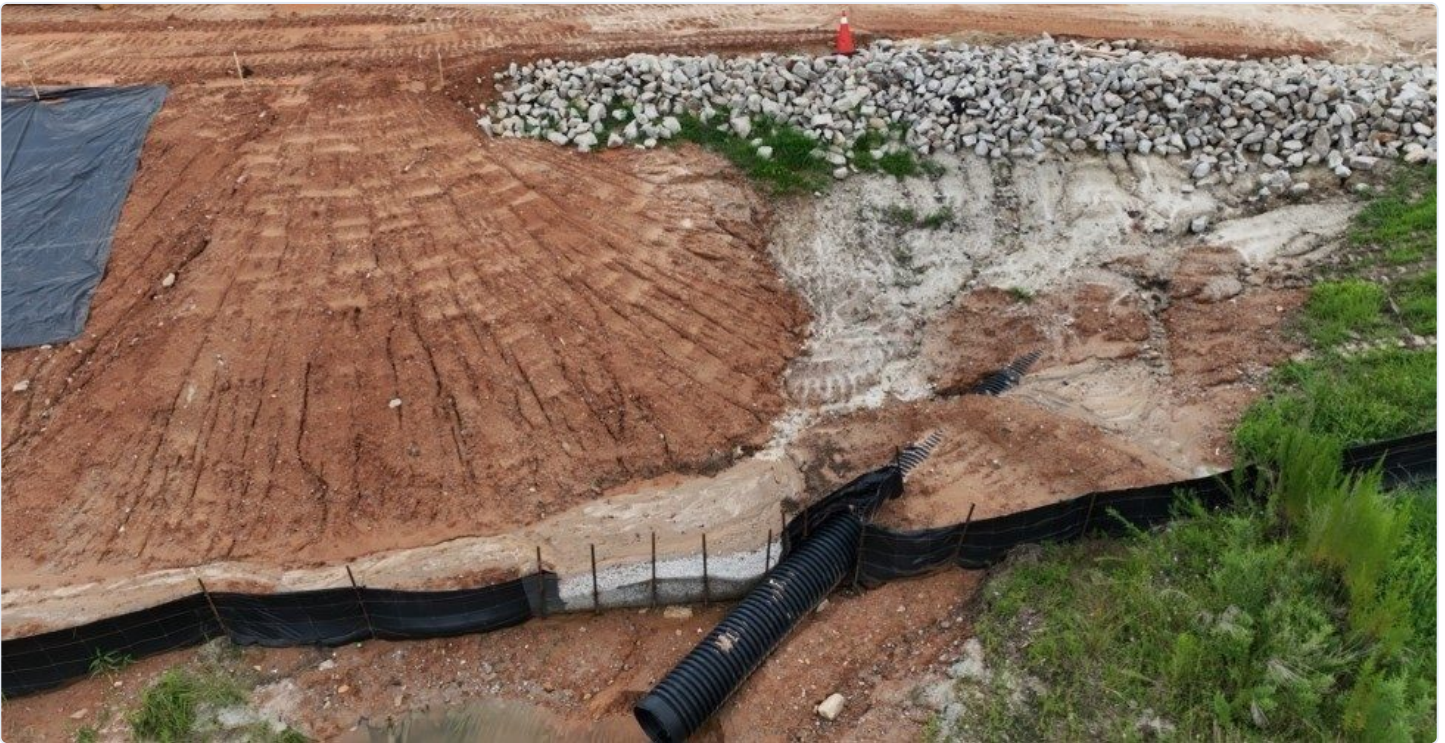
| LOCATION | OBSERVATION | SEVERITY |
|---|---|---|
| Erosion control | Rip-rap apron and outlet protection recorded as installed (Fig. 5) | LOW |

*Fig. 5 — Erosion-control detail. Rip-rap apron and outlet protection as installed, at low altitude.*
