# BEFORE / AFTER DOCUMENTATION

Job completion evidence package · paired pre-work and post-work aerial documentation

| Client | Sample Roofing Co. (fictitious) | Report ID | MWA-BA-SAMPLE-0001 |
| Scope of work | Full roof replacement — architectural shingle | Issued | Sample |

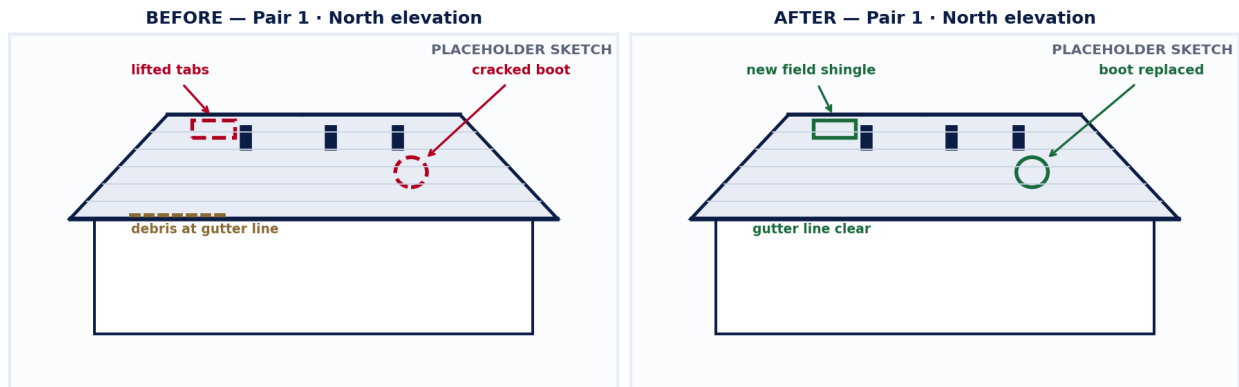
**PLACEHOLDER SKETCH** — stands in for the matched aerial frames. A delivered report carries the actual photographs at full resolution, annotated exactly as shown here: conditions ringed in red before the work, in green after it.

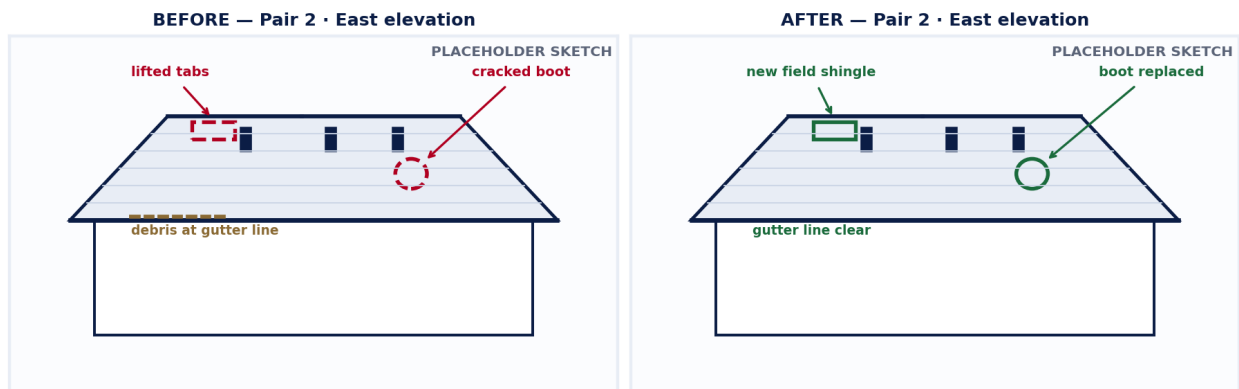
**PLACEHOLDER SKETCH** — second matched pair. Both flights are flown from the same altitude and heading so the frames line up when placed side by side.
