# QUARTERLY PROPERTY SURVEY

Portfolio condition summary · documented condition history per property

| Client | Sample Property Group (fictitious) | Report ID | MWA-QPS-SAMPLE-0001 |

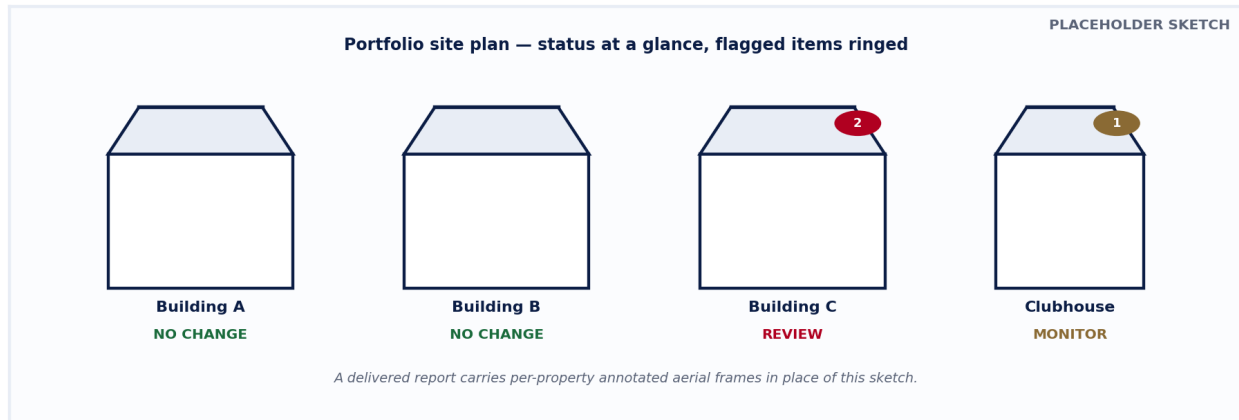
**PLACEHOLDER SKETCH** — portfolio at a glance. A delivered report carries per-property annotated aerial frames in place of this diagram, with each flagged item shown on the elevation where it was observed.
