## INSURANCE SUPPORT PACKAGE

Per-slope evidence package for adjuster review · single-family residence · capture date withheld

| <b>Property</b> | Single-family residence · address withheld | <b>Report ID</b> | MWA-SMP-0006 |
| <b>Structure</b> | Hip-and-gable roof, architectural asphalt shingle | <b>Loss type</b> | Wind — cause not determined here |

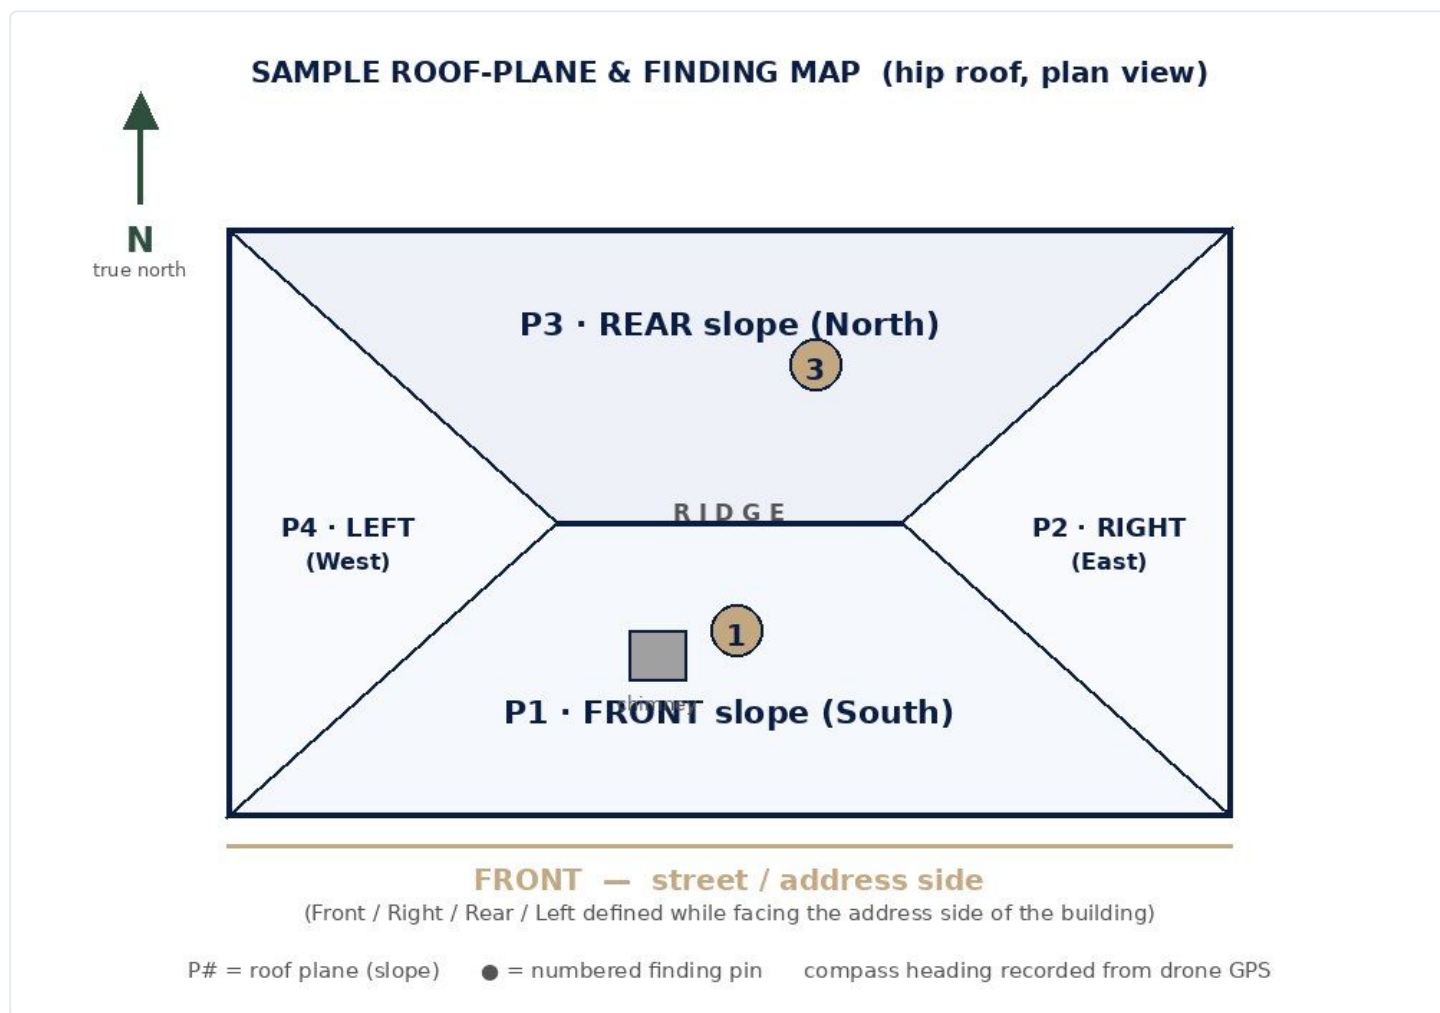
Fig. 1 — Roof-plane map. Planes numbered P1 to P4 from the address side — the reference every other frame is captioned against.
