## LAND & SITE INTELLIGENCE REPORT

Property documentation · extent, access, drainage and erosion control · capture date withheld

| <b>Property</b> | Parcel address withheld | <b>Report ID</b> | MWA-SMP-0005 |

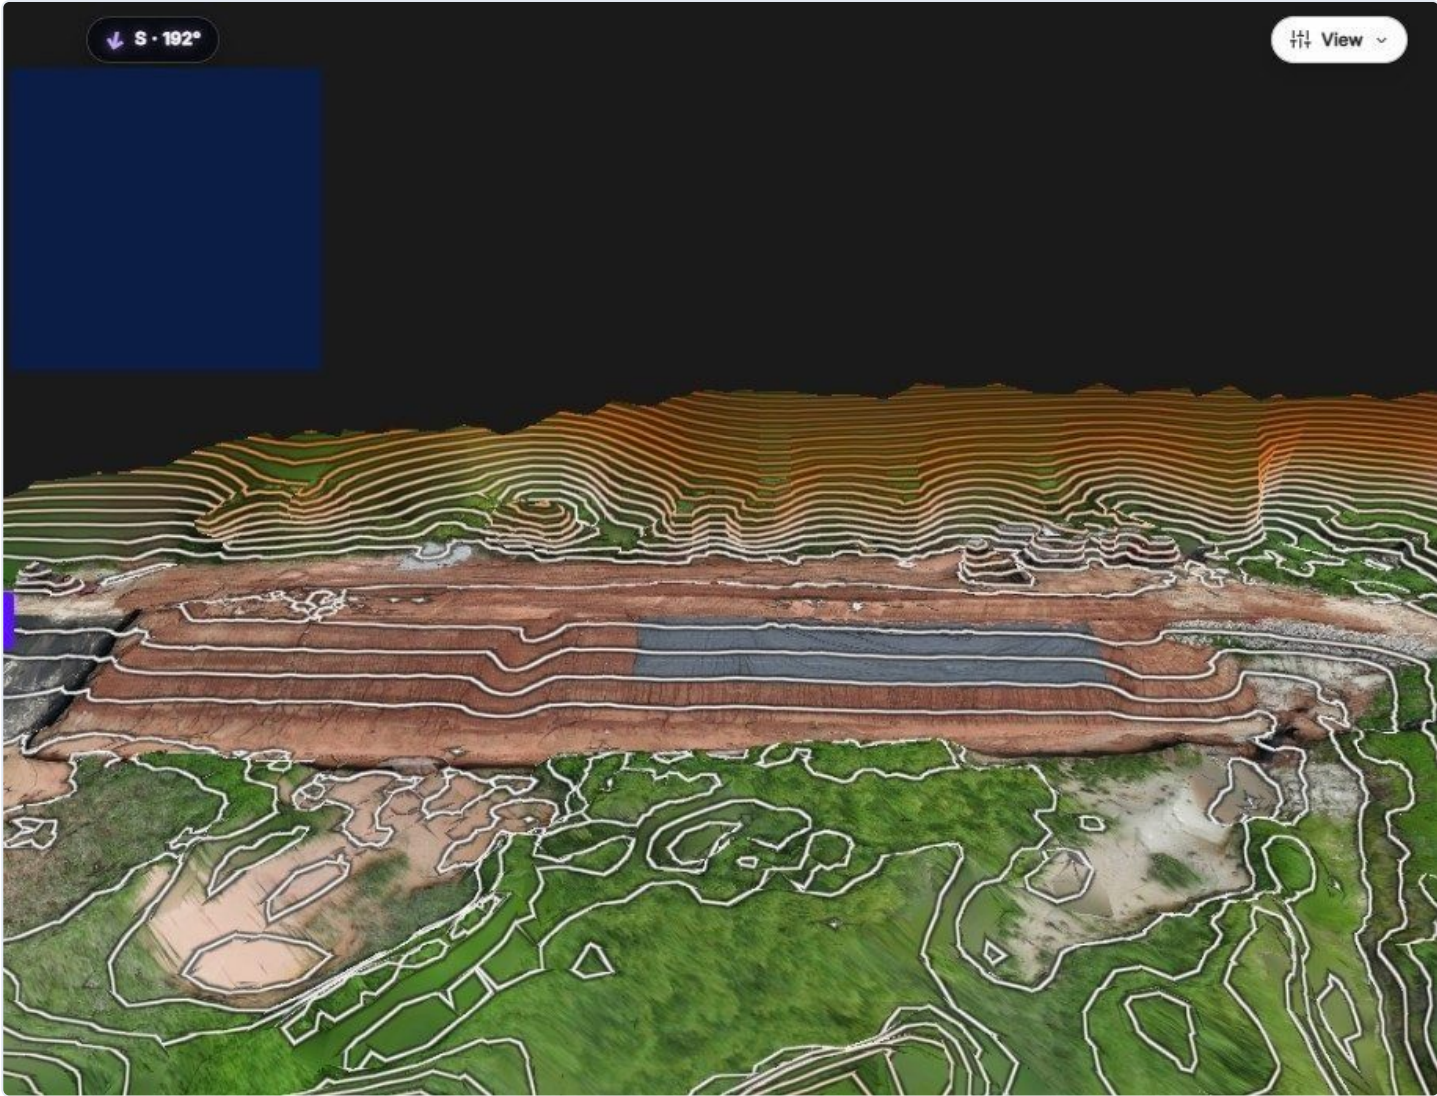
Fig. 6 — Optional add-on — 3D terrain visualization with contour overlay, generated by third-party software from the flight imagery. Not a survey and carries no measured accuracy.
